**Investigation And Field Observation On The Effects  
Caused By The Earthquake On 12<sup>th</sup> May 2008  
In Sichuan Province**

**(Field trip from 18<sup>th</sup> August 2008 – 23<sup>rd</sup> August 2008)**

**YUEN Kam Ming Dennis  
(CGeol FGS CPGHK)**

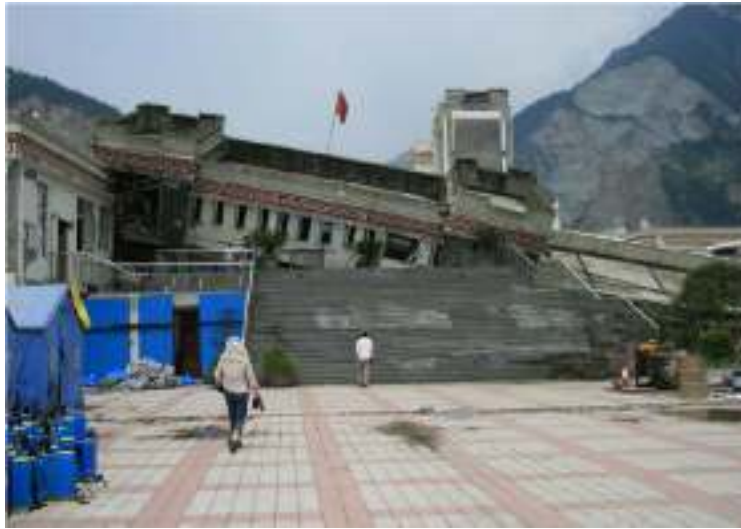
At 漩口小学, only one and a half storey (out of the original several storey school building) remained tilting above ground. The houses and factories in the vicinity of the school had all damaged to great extent. People with a clear mind would agree that there were still

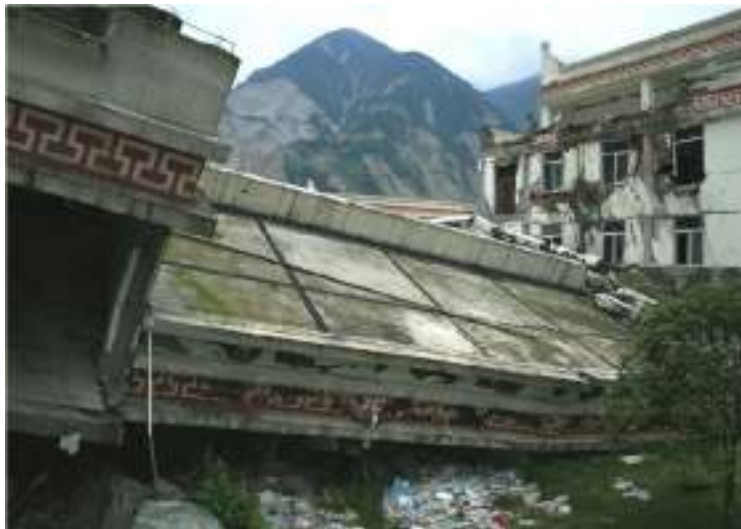
We had the haunted feeling as if we were at the moments of the earthquake. The boundary wall of the school at the front entrance was also forced to turn in an anti-clockwise direction for approximately 50mm due to shearing stress generated by the

earthquake which was also evidenced from orientated fractures on the ground. The National flag at the school was however still flying.

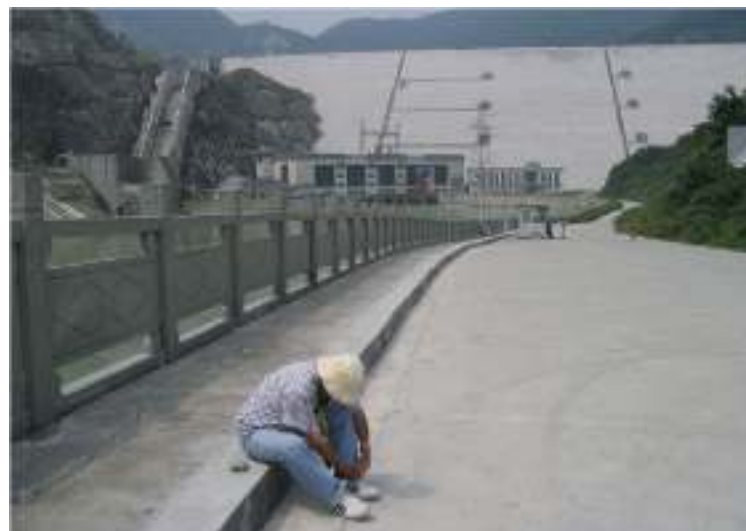
We then headed to 紫坪鋪壩 which was the most famous dam that had resisted the 512 Earthquake. We were impressed by the favourable conditions of the dam that had no significant damages after the earthquake. The road leading to the main dam showed a few cracks on the pavement and some minor cracks on the dam surface had been repaired and were considered insignificant to the integrity of the dam structure at the time of our visit.

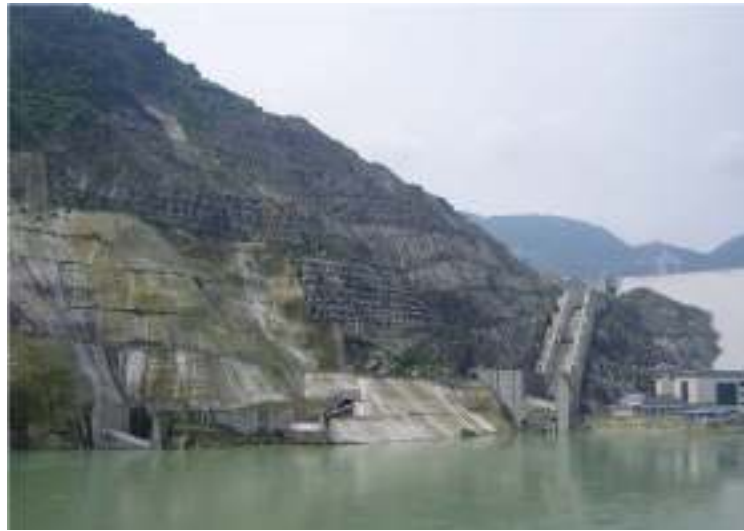
We recalled the briefing by Professor ZHANG on 18<sup>th</sup> August 2008 at the Sichuan University about the design of the main dam. Large numbers of rock bolts were installed on the slopes adjacent to the main dam proved effective after the

512-Earthquake with such large magnitude. There were only one or two places where minor landslides were observed at the side of the reservoir.

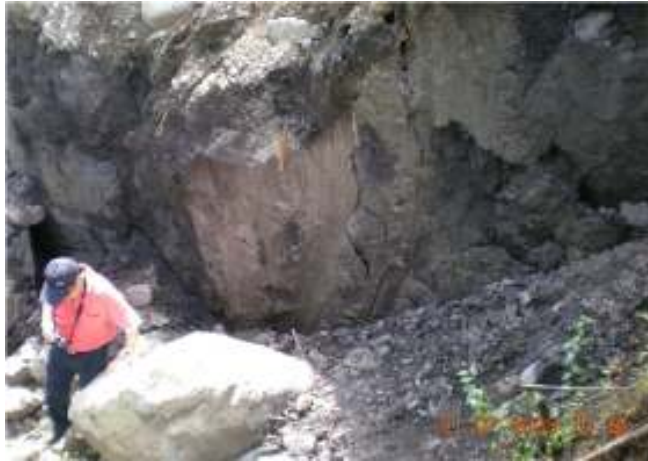
The surface rupture there was the result of an uplift of ground caused by the 512-Earthquake. There were very clear slickensides seen on the surface rupture some time ago but it became barely visible due to the effect of rain.

Fossils of plant root and stem were discovered from the exposed outcrop by Mr. LEE C.M. in early August 2008. A thick layer of debris flow deposits was identified above the coal-bearing shale. We examined the vicinity of the slip scar and observed that there were many pitch-black outcrops of coal-bearing shale along the side of 白沙河 (Bai Sha He). The vertical displacement caused by the slip was measured to be 4.5m.

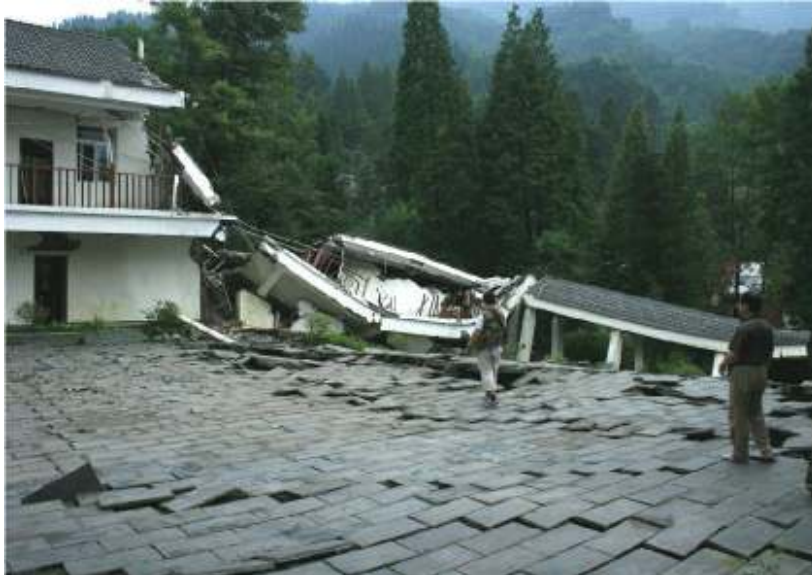
Inside the courtyard of the 解放軍訓練中心, a few widely opened tension cracks were running parallel to each other on ground across a wrecked building with maximum separation of 1.1m and the tension cracks were sloping to the downthrown side of the fault.

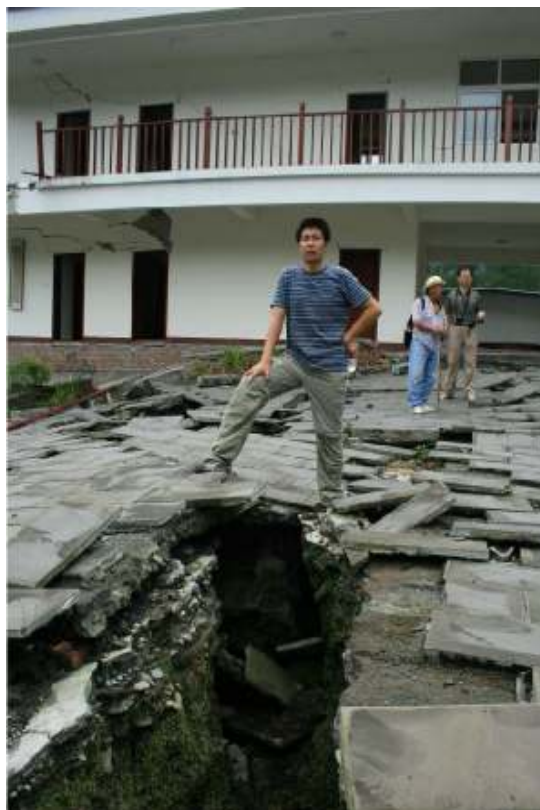
It was worth-noting that some trees in the courtyard along the wrecked buildings were wilted due to lost of groundwater after the earthquake.

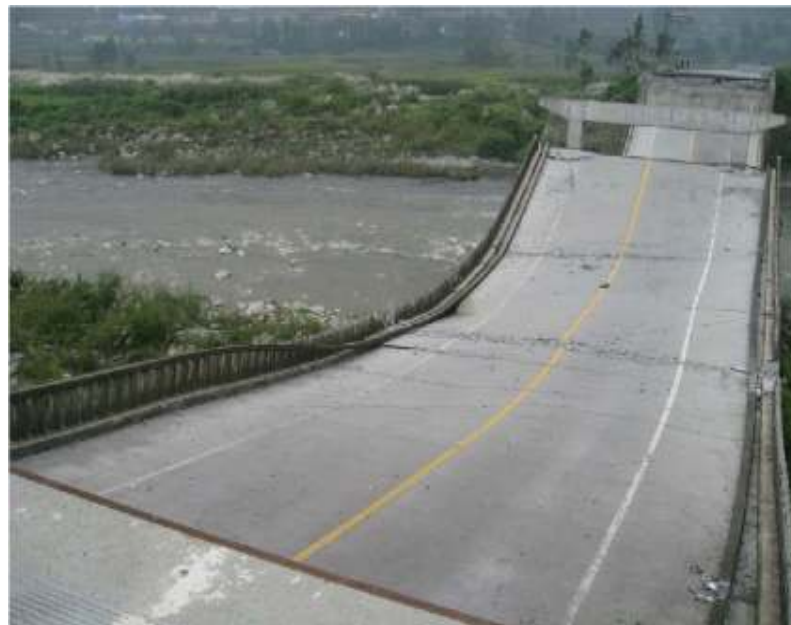
In this earthquake, the highway bridge was totally collapsed into several sections, the bridge columns were detached, joints dislocated with some of the steel reinforcement distorted and exposed; the road surface of the bridge was cracked and offset.

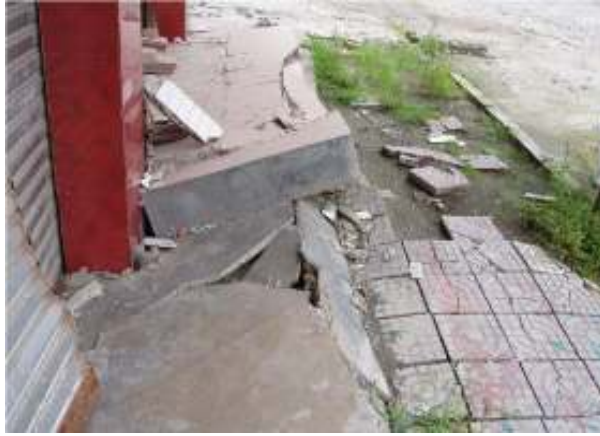
With about 20 minutes drive from 小魚洞 bridge, we arrived at 小魚洞鎮 where the fault was recognized running through the ruins of houses. The totally shattered roof tiles and bricks on ground reflected the high intensity level caused by the earthquake. The strike of the fault continued along the ruins of houses into the maize fields and to the river.

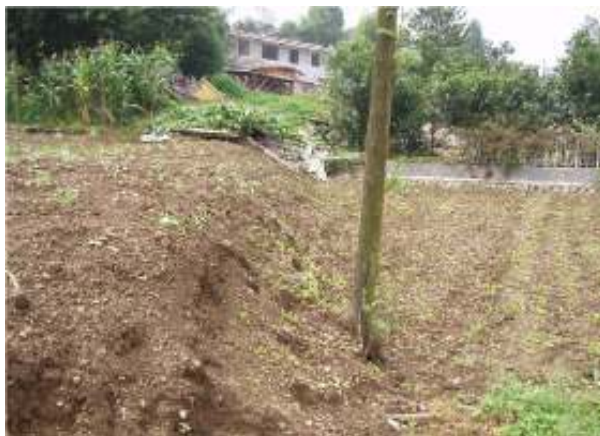
On one locality along the trace, a parapet wall of approximately 5m long outside a house were found collapsed to one side which was

considered to have caused by shearing effects of the earthquake.

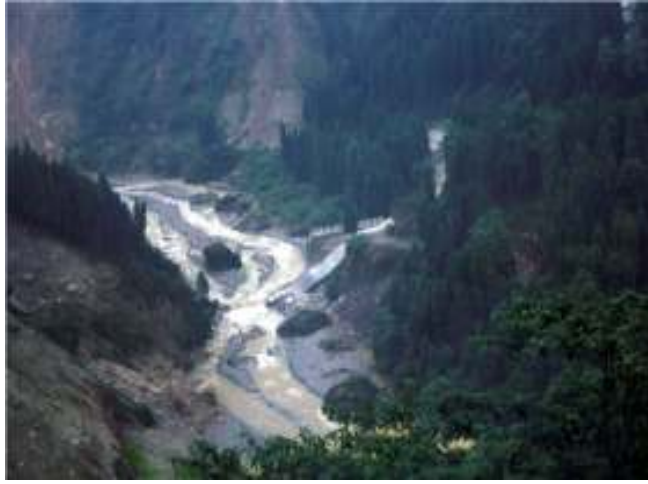
At about 3:00 p.m., our vehicles were heading towards 銀廠溝 which could have been named after its steepness and depth of the gorge. A road bridge was seen collapsed and landed on the riverbed of the gorge. The road condition became worse due to the damages caused by the landslide as our vehicles proceeded.

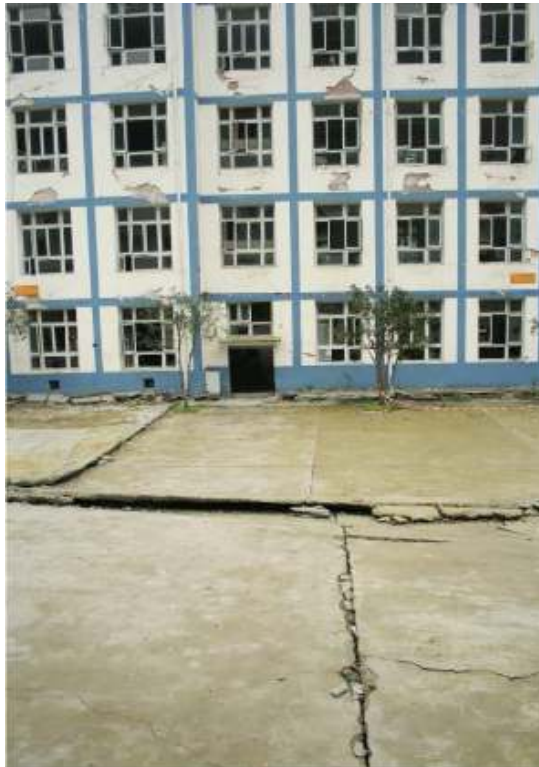
The school building on the up-thrown side of the fault remained intact and surprisingly found no damages whereas the school building on the opposite side on ground suffered broken windows and diagonal shearing damages. The houses at both ends of the school buildings were however all torn down to rubbles due to the earthquake.

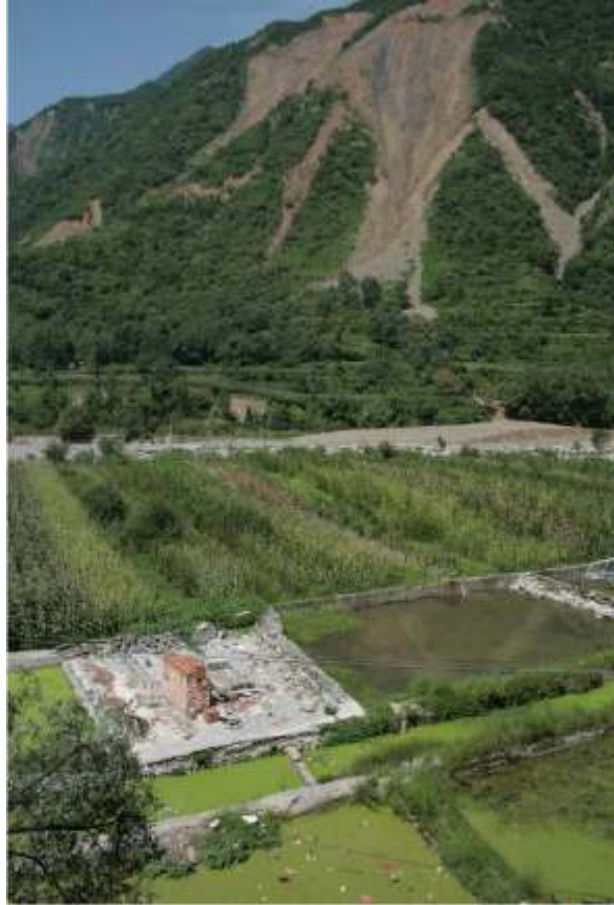
A fish/duck pond was dried up due to the uplift of ground caused by the fault. It was obvious that the ponds adjacent to it were still with water. Landslip traces like graffiti on the mountain surface were commonly seen over this region.

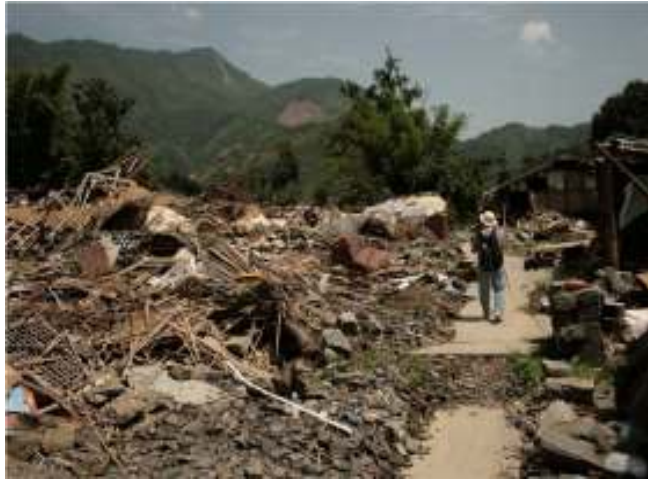
the damages were caused by an uplift of ground with vertical displacement of 2m to 3m. We could not continue further because the collapsed houses blocked the path.

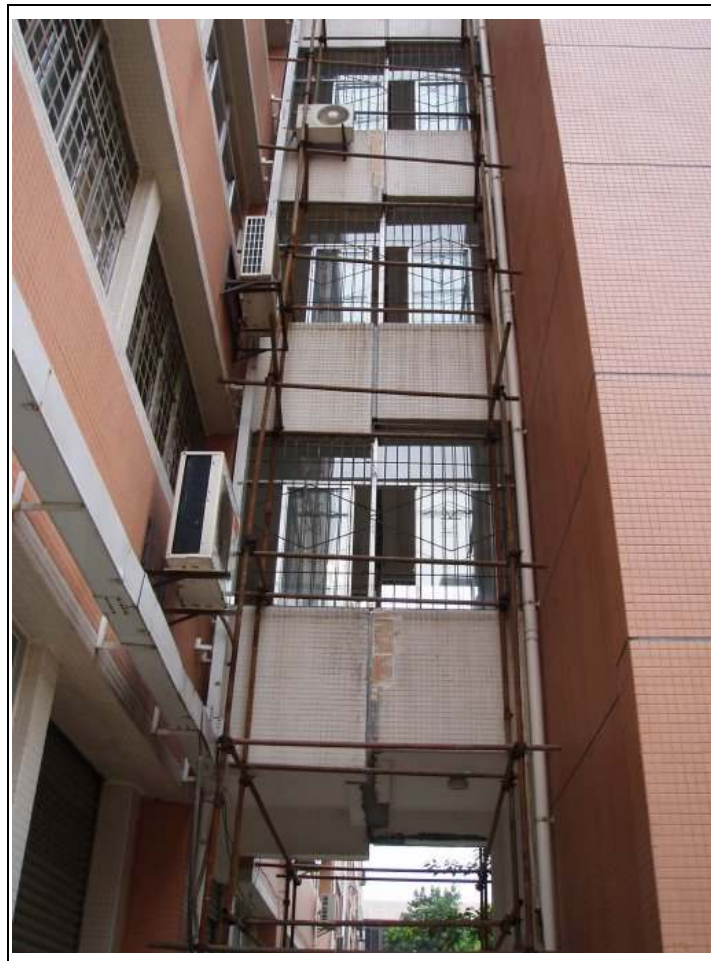
A6: Building within the campus of Sichuan University was damaged.

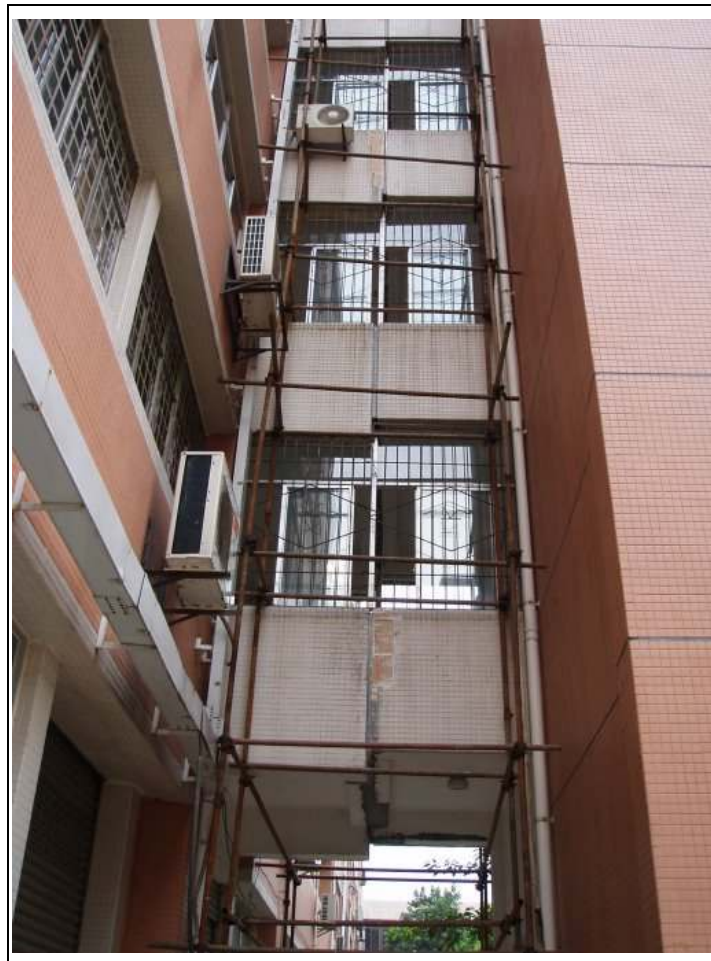
A6: Building within the campus of Sichuan University was damaged.

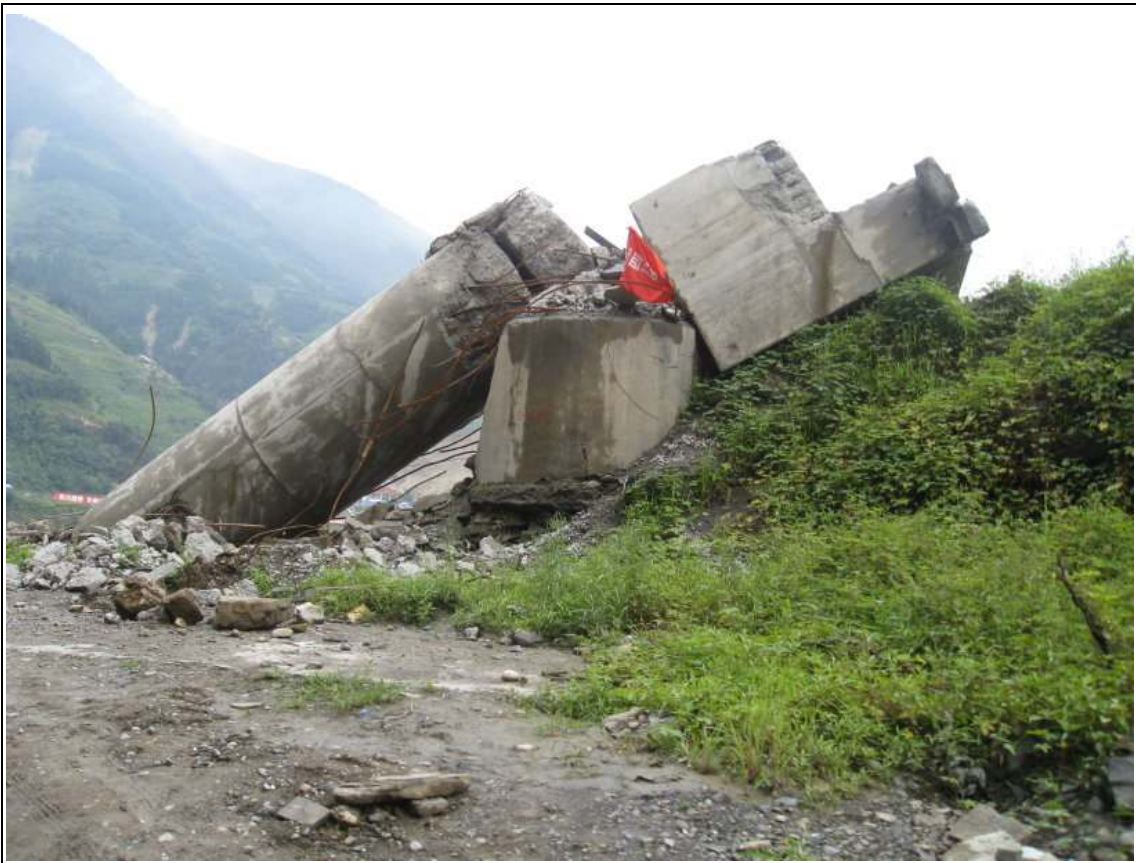
B7: 白花大桥 was down with broken columns and pier of the highway bridge on the verge of the river (白水河).

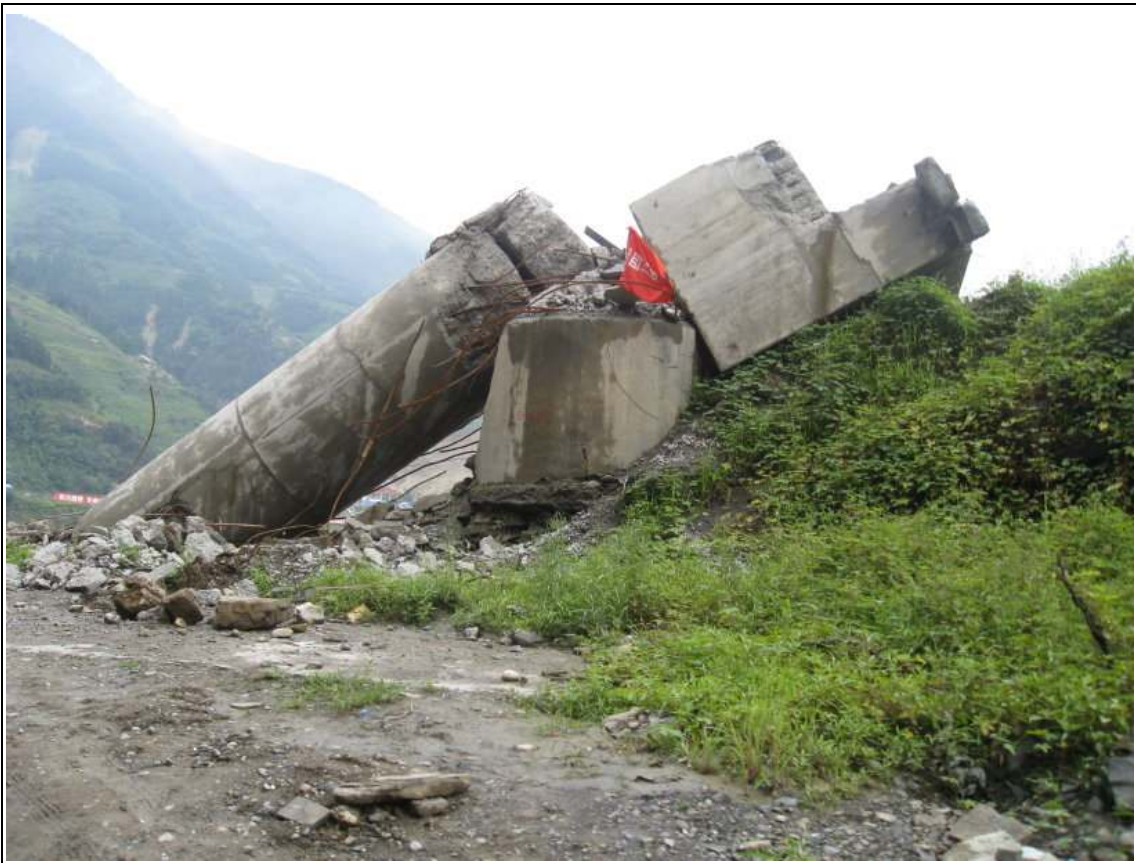
B7: 白花大桥 was down with broken columns and pier of the highway bridge on the verge of the river (白水河).

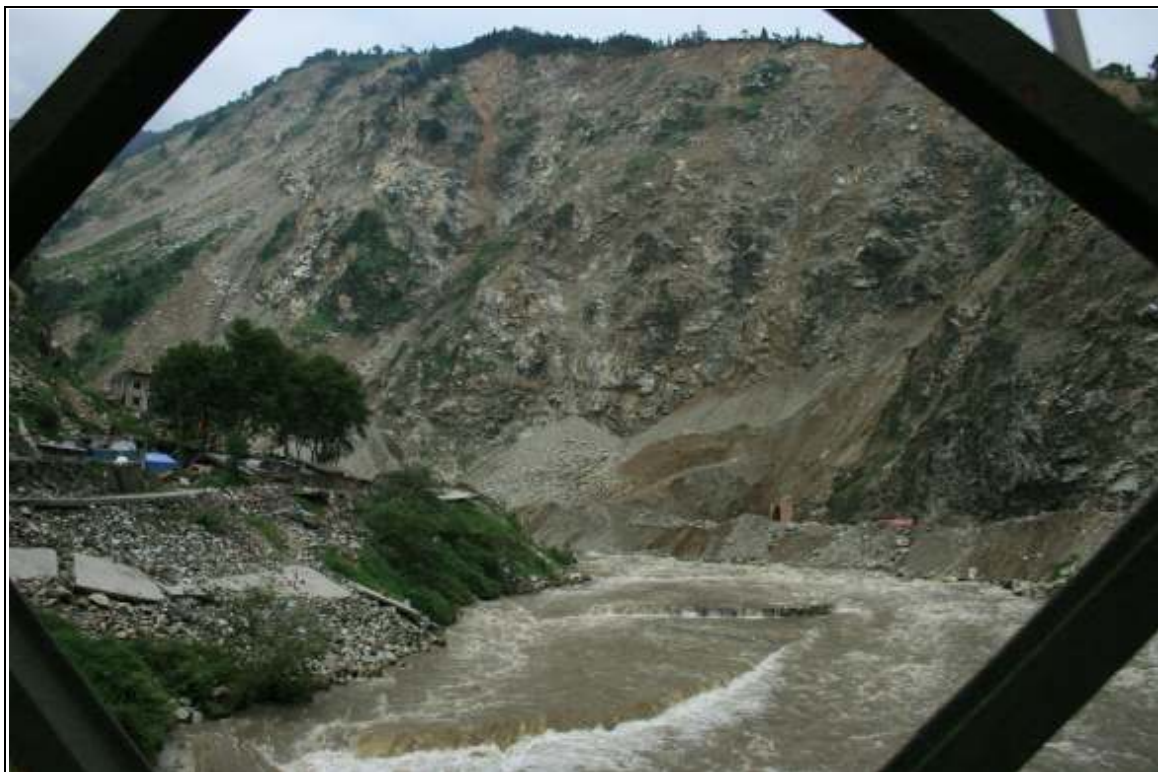
B26\_The mountain was totally stripped off and the river bed was disrupted in 映秀 Town. 百慈大橋 was collapsed. A temporary steel bridge was erected for the transportation of daily needs to the villagers.

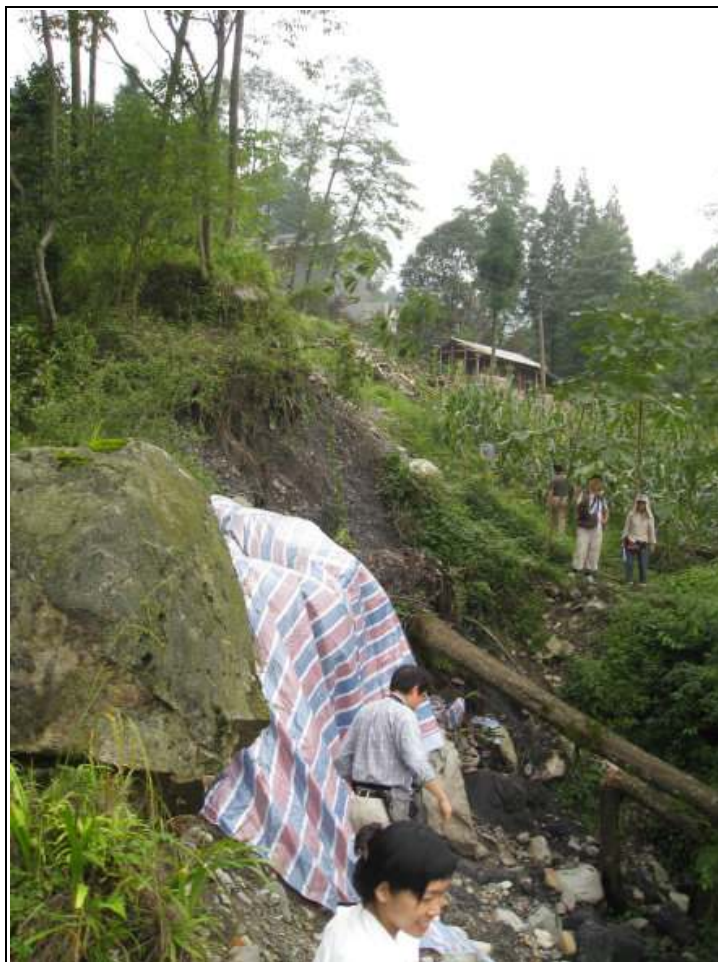
B30: a surface rupture of coal-bearing shale was observed on a slip scar covered by a tarpaulin sheets to protect it from weathering for inspection

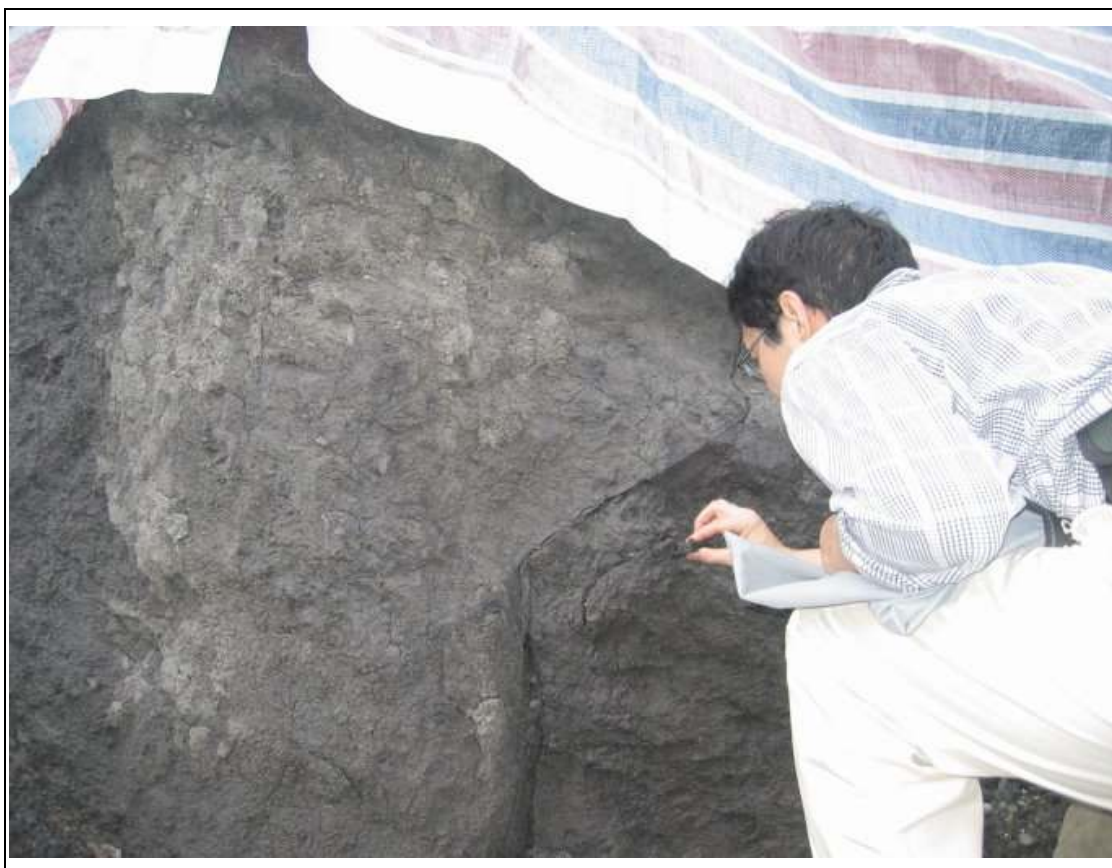
B31: Coal-bearing altered shale where slickensides were observed at 八角廟. The surface rupture was the result of an uplift of ground caused by the earthquake.

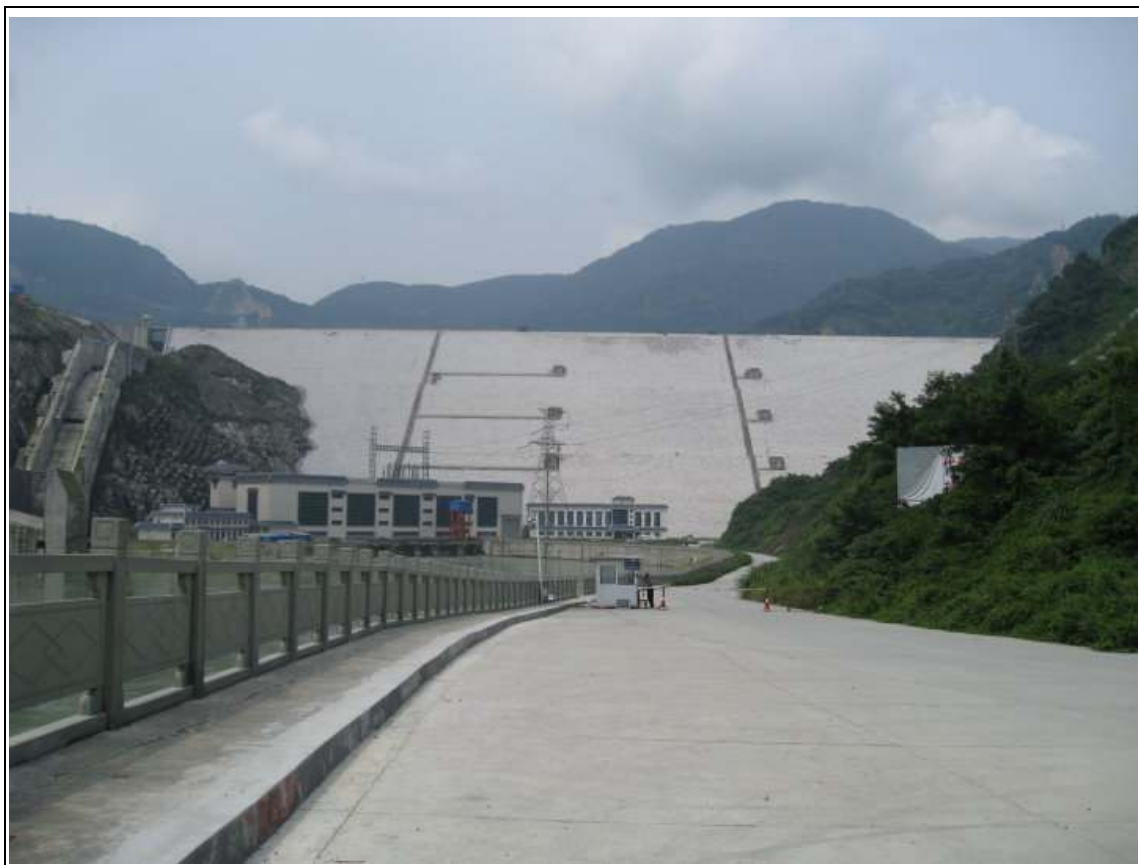
B33: 紫坪壩大橋\_Main dam was reported to have no significant damages

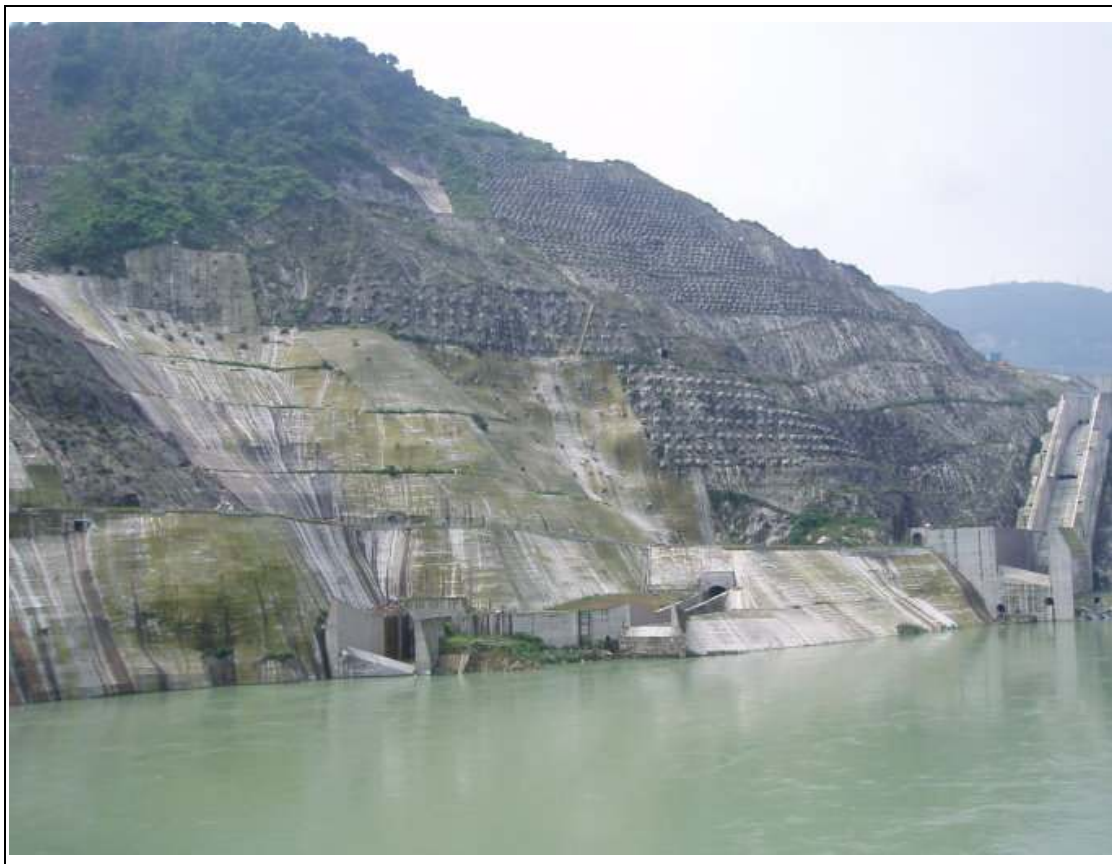
B34: Numerous rock bolts were planted on slope next to the main dam of 紫坪壩大橋 had proved that the dam had resisted the earthquake of such great magnitude.

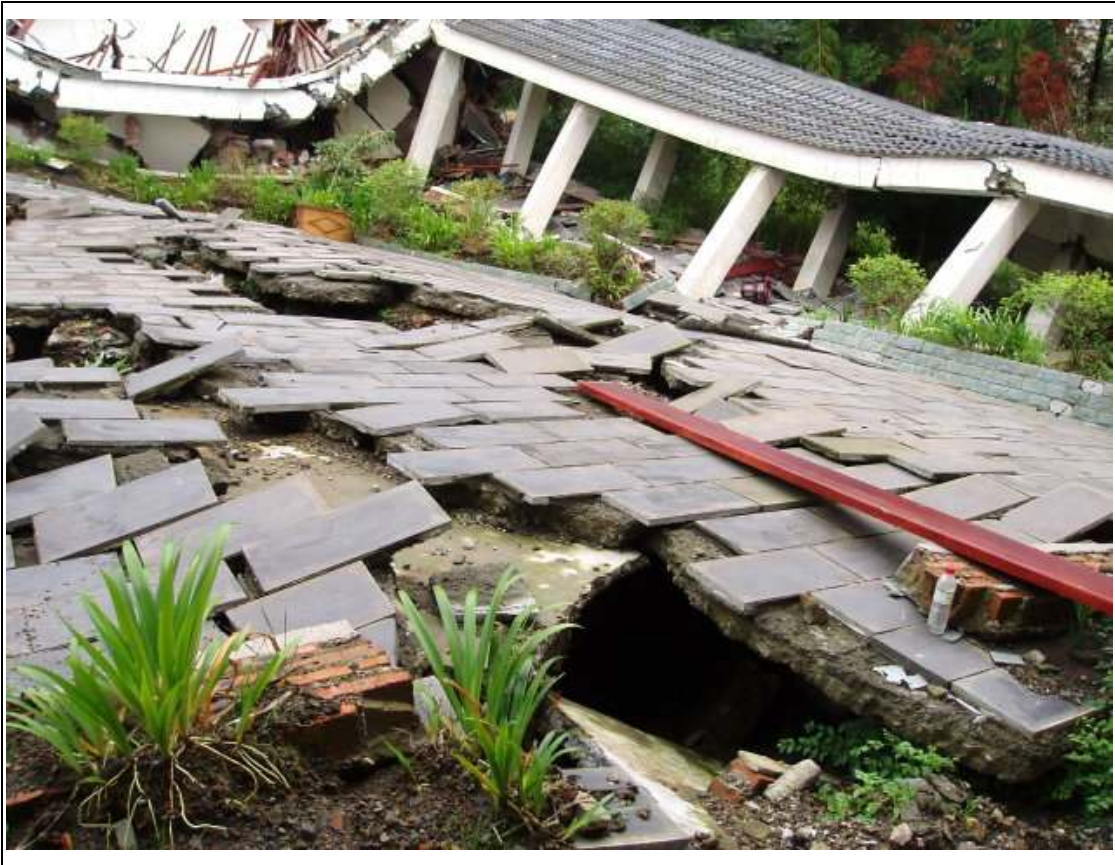
B38: 解放軍訓練中心 (PRC Army Training Centre) at 紅口鎮 - The structure were seriously damaged by the quake leaving behind the wide and deep tension cracks on ground.

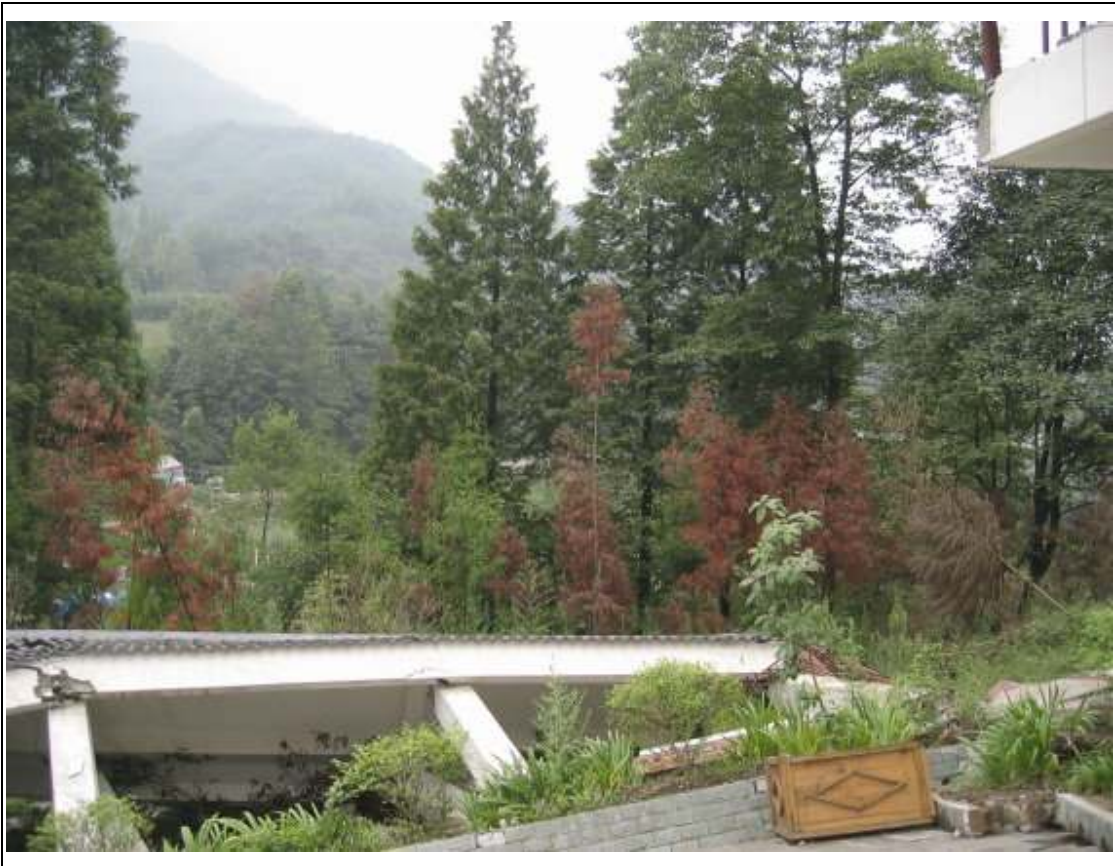
B39: 解放軍訓練中心 (PRC Army Training Centre) at 紅口鎮 - The trees adjacent to the fault disruption were wilted with brown colour, other trees unaffected remained green.

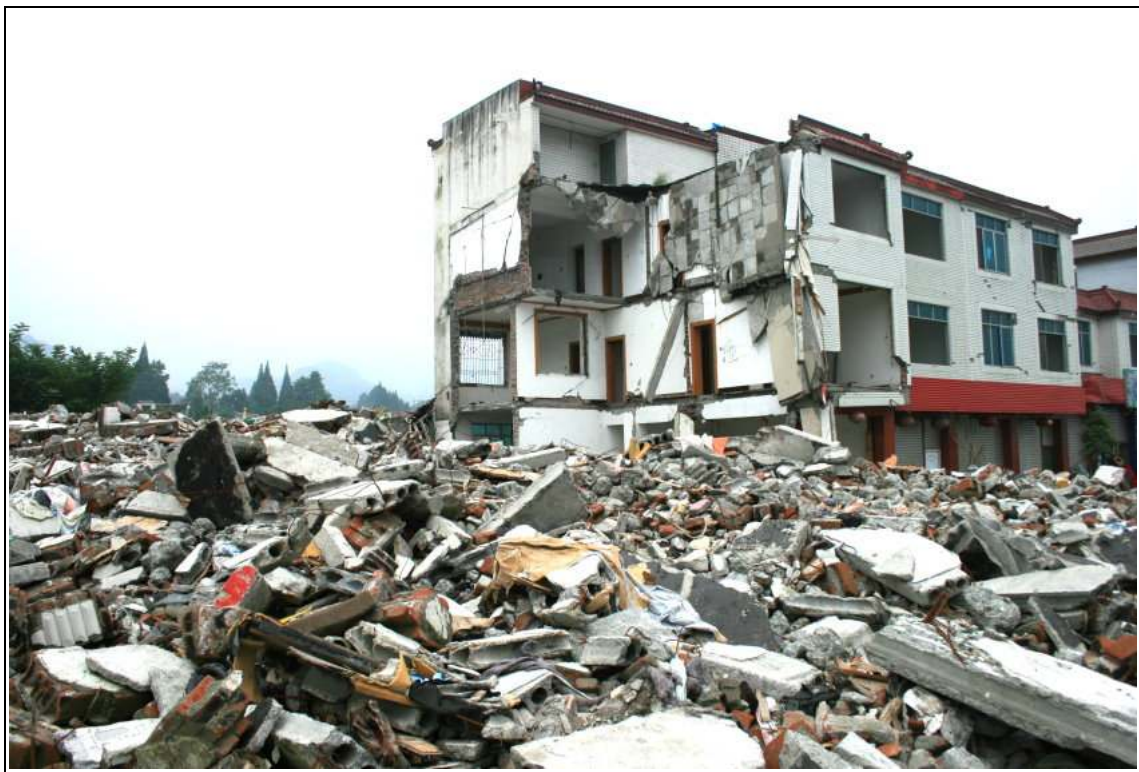
C12: The wreckage of houses indicated that the fault passed underneath them.

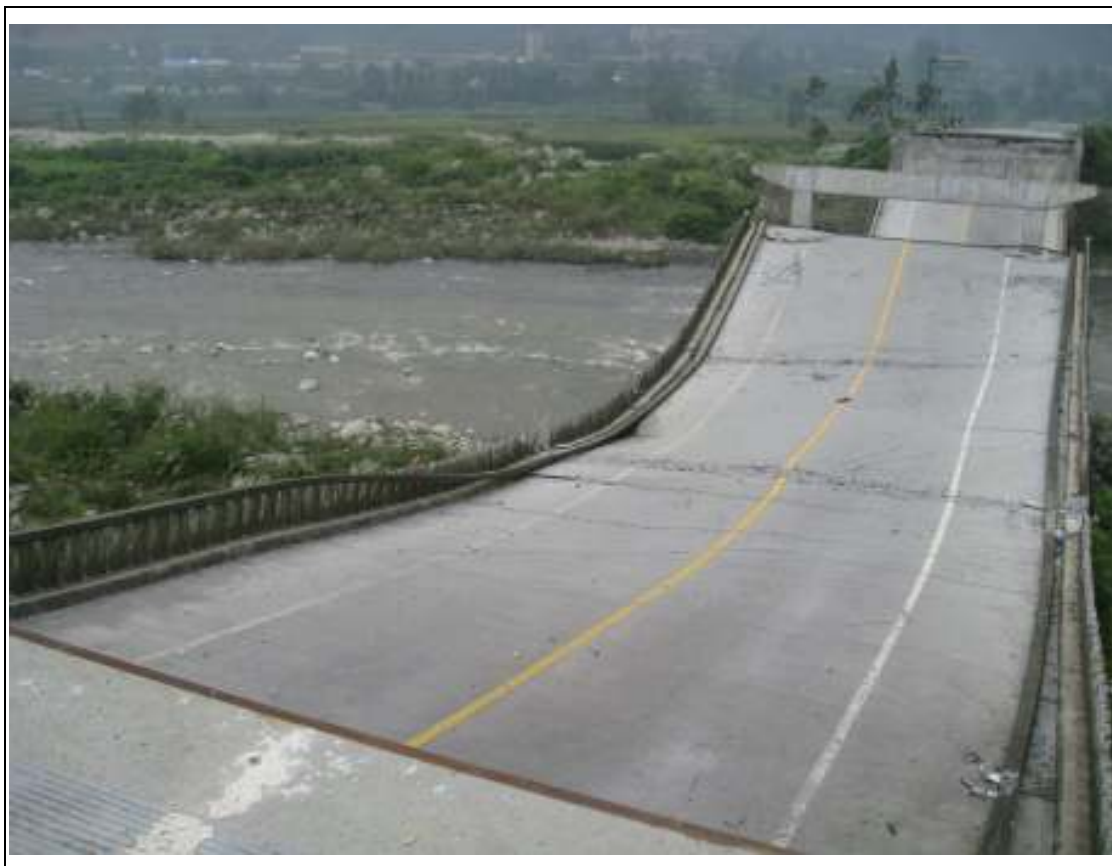
C5: The highway bridge.(小魚洞大橋) was collapsed into several sections, the bridge columns were detached, joints dislocated with some of the steel reinforcement distorted and exposed; the road surface of the bridge was cracked and offset.

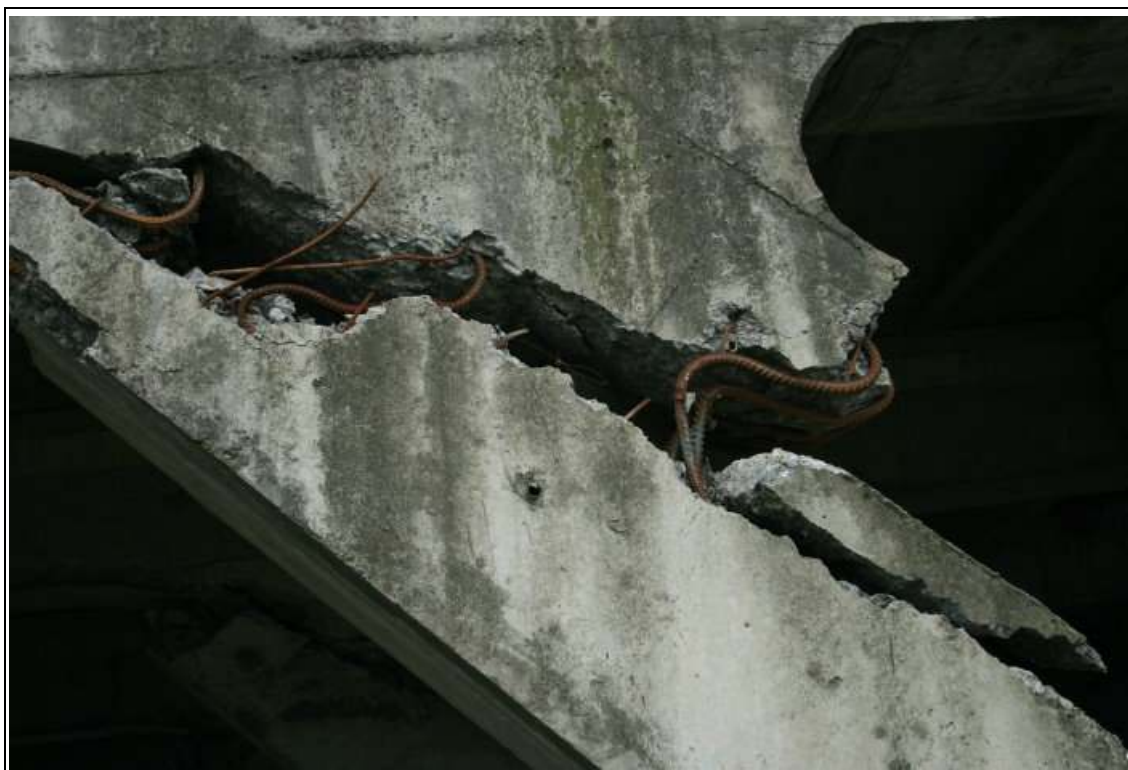
C6: Distorted reinforcement of the 小魚洞大橋

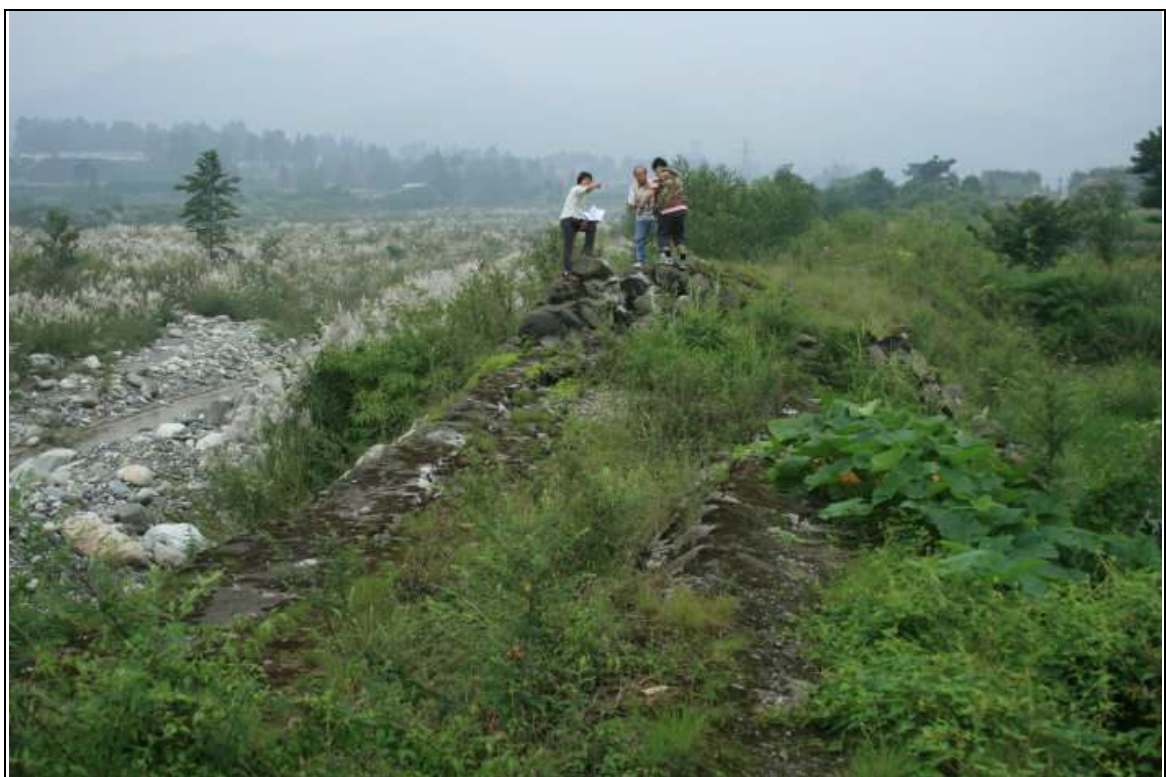
C8: Geological investigation for fault trending, dip and type of fault causing the huge damage to 小魚洞大橋.

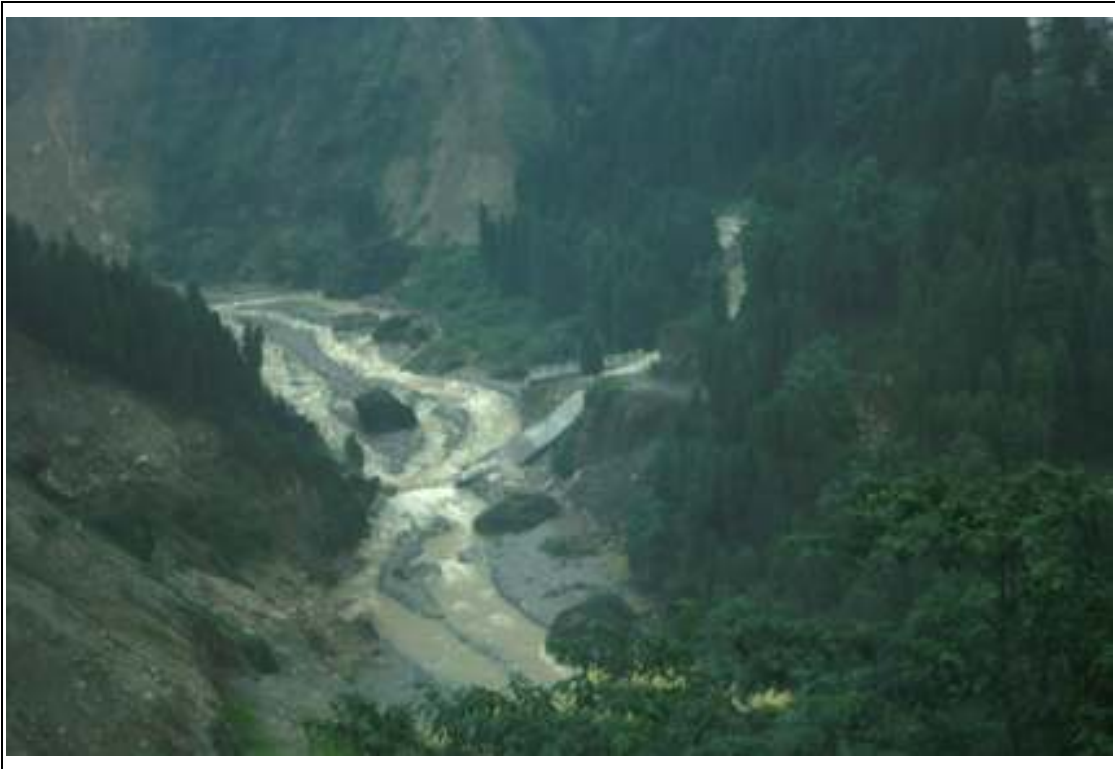
C18: A collapsed bridge was found in the river at 深溪溝 (Shenxigou).

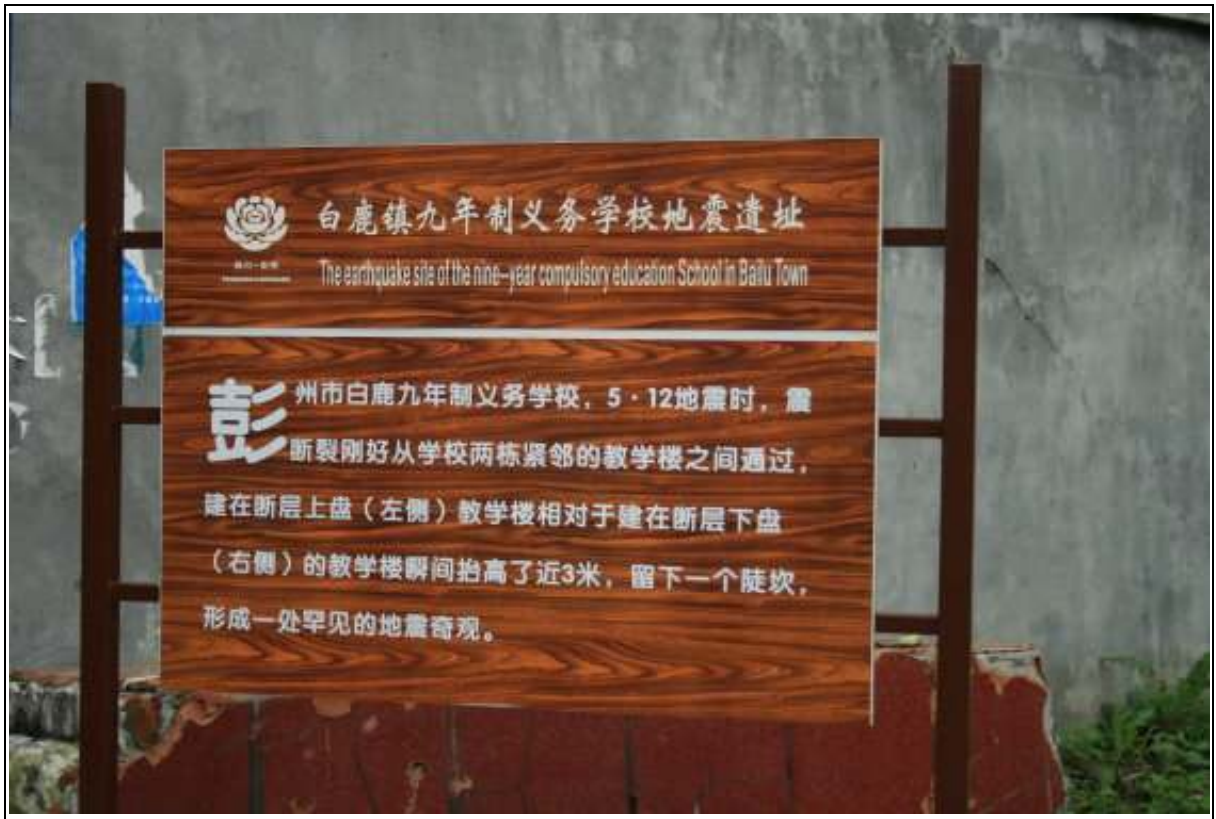
C22: There were 2 school buildings in 白鹿中学 separated by the sinistral fault. The school building on the downthrown side of the fault had minor damages while the school building on the upthrown side remained intact.
