**Investigation And Field Observation On The Effects  
Caused By The Earthquake On 12<sup>th</sup> May 2008  
In Sichuan Province**

**(Field trip from 18<sup>th</sup> August 2008 – 23<sup>rd</sup> August 2008)**

**YUEN Kam Ming Dennis  
(CGeol FGS CPGHK)**

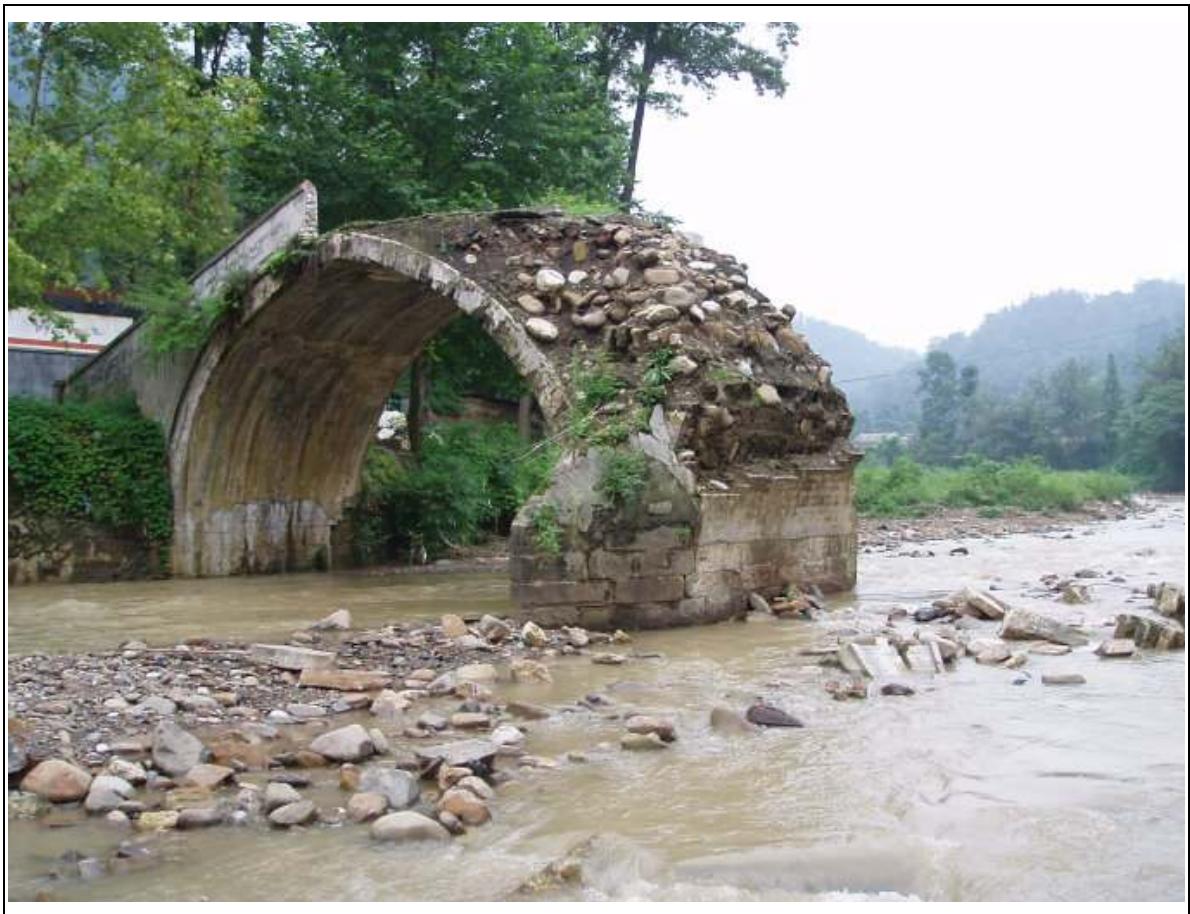
C22a: The Sino-French Bridge near the 白鹿中学校 built as an access to the school across a river was collapsed during the earthquake. The local villagers had then erected their own temporary bridge by putting 7 thick bamboos together across the river.

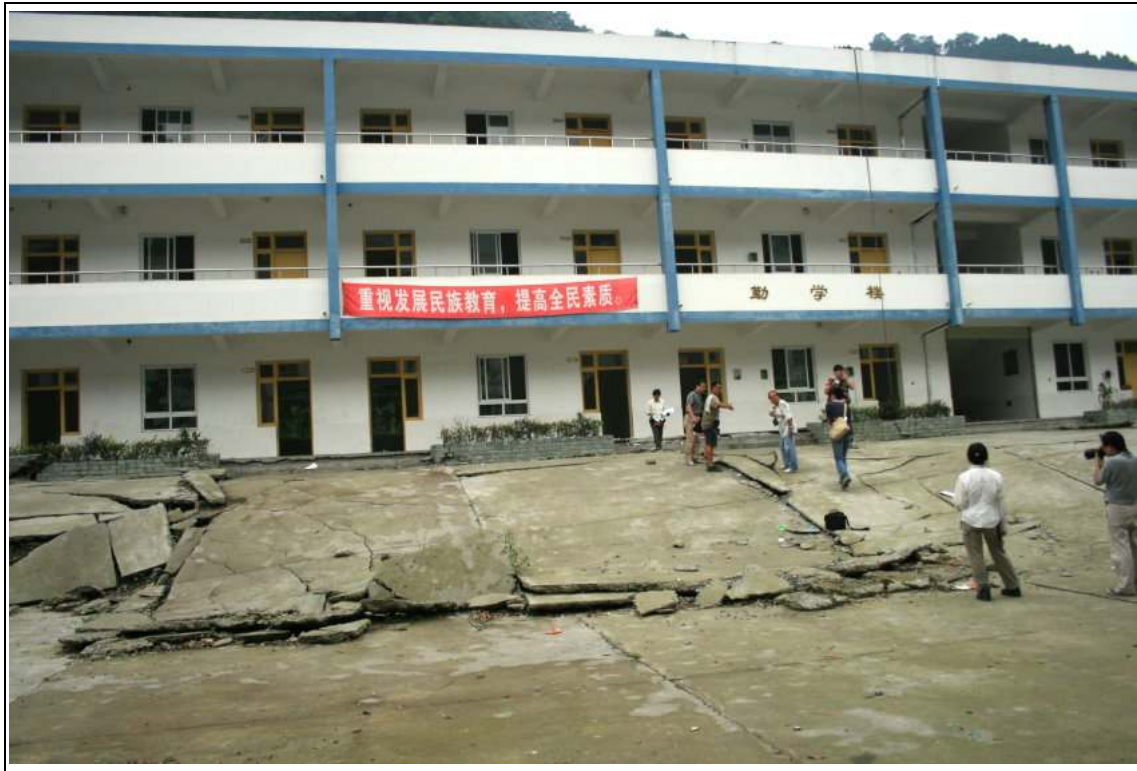
C23: The front view of the school building on the up-thrown side of the fault. This is type-locality of a sinistral reverse-fault caused by the earthquake. It had produced a vertical displacement of 2.2m to 2.3m and sinistrally displaced 4m at the school site.

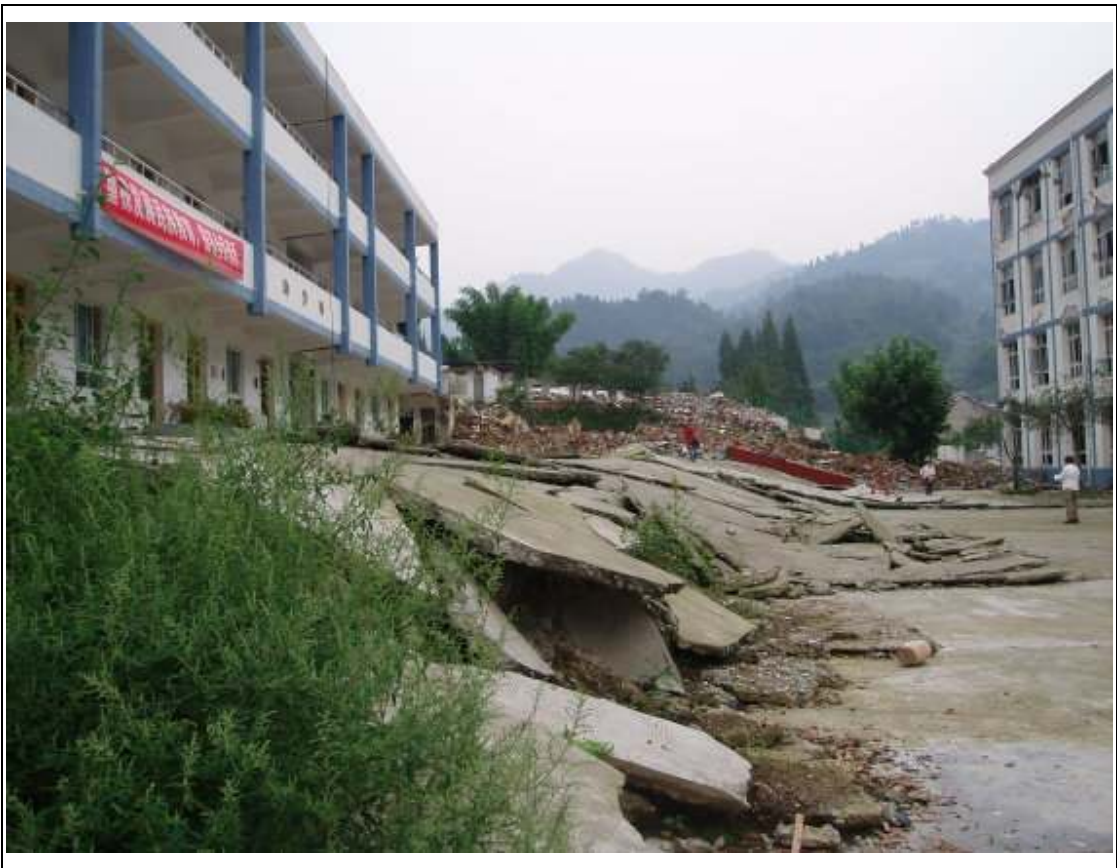
C25: The upthrown side of the school remained intact whereas the school at the downthrown side was slightly damaged

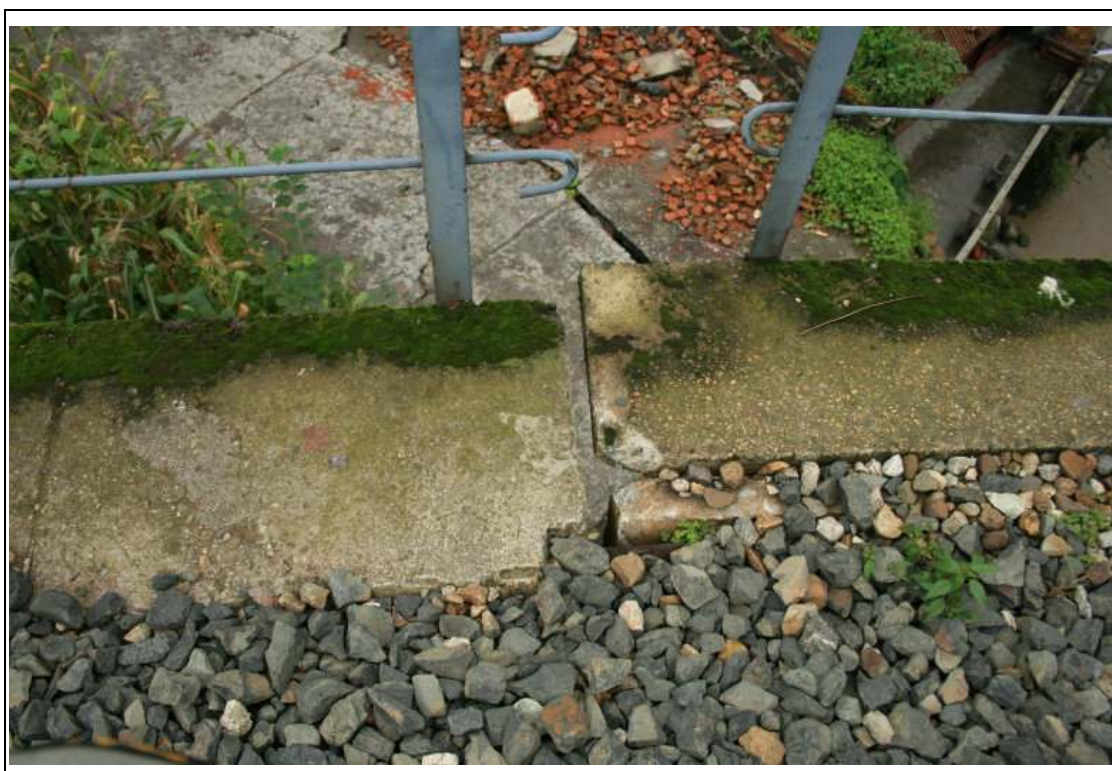
D10: 紅白鎮 (Hong Bai Town) - The railway bridge was also damaged.

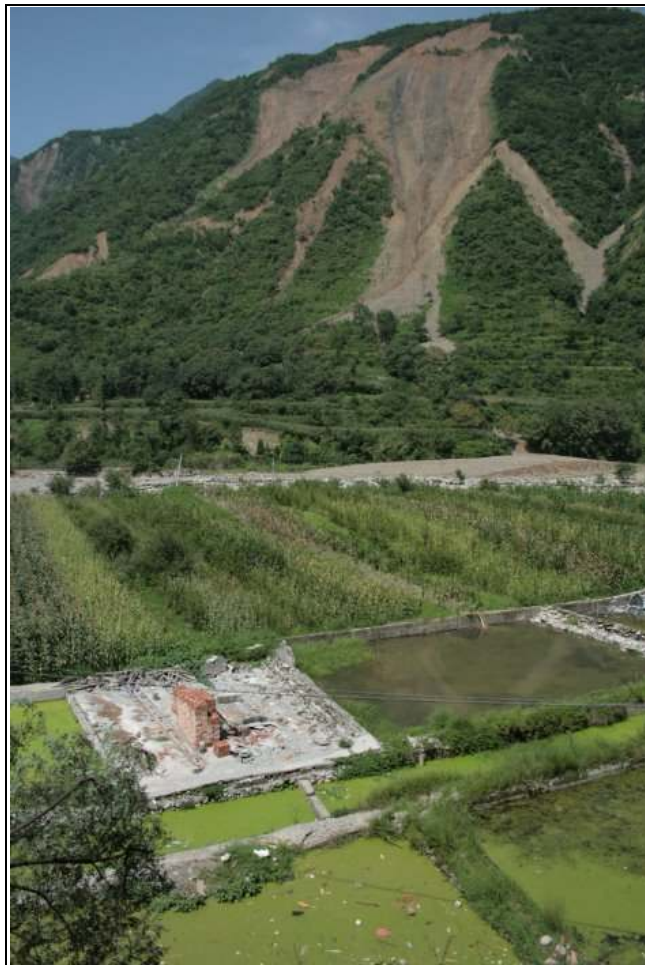
E2: 平通鎮 (Ping Tong Town) - A fish/duck pond was dried up due to the uplift of ground caused by the fault..

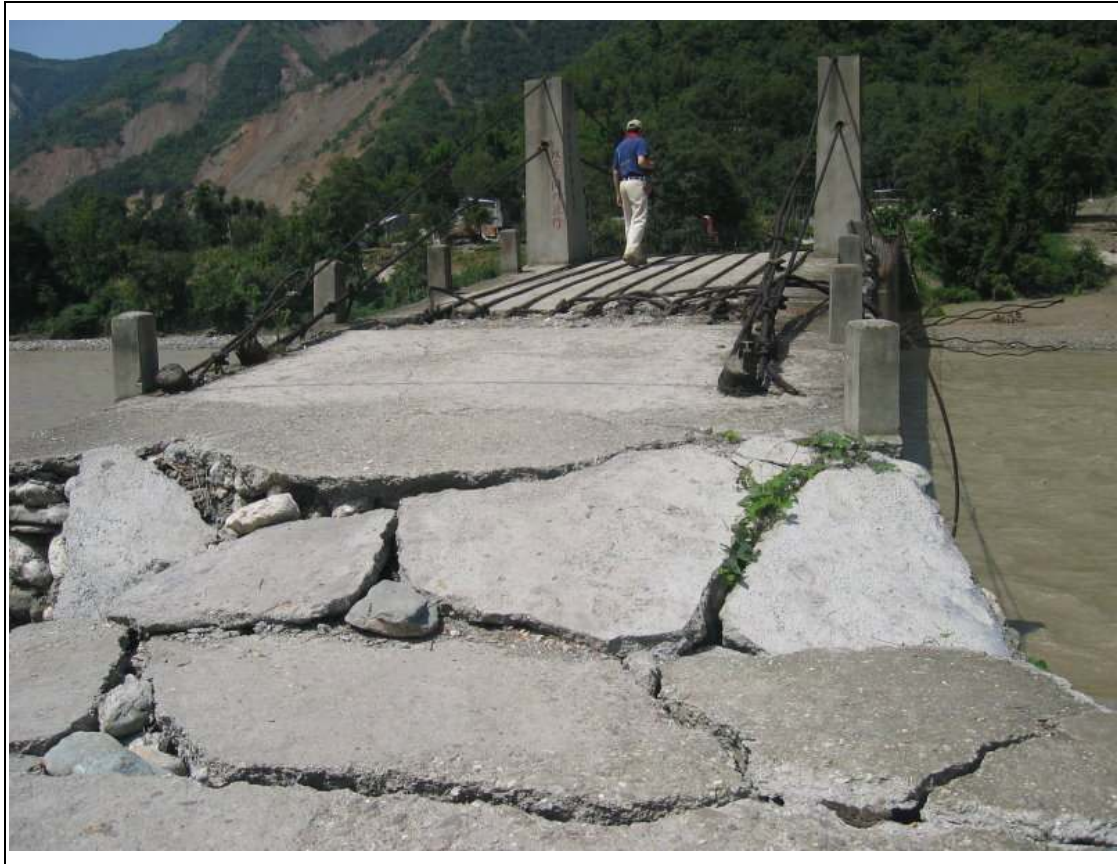
E4a: During the earthquake, part of the bridge was damaged.
