Non-textbook Flowslides in Fine-grained Colluvium

Oldrich Hungr

University of British Columbia, Canada

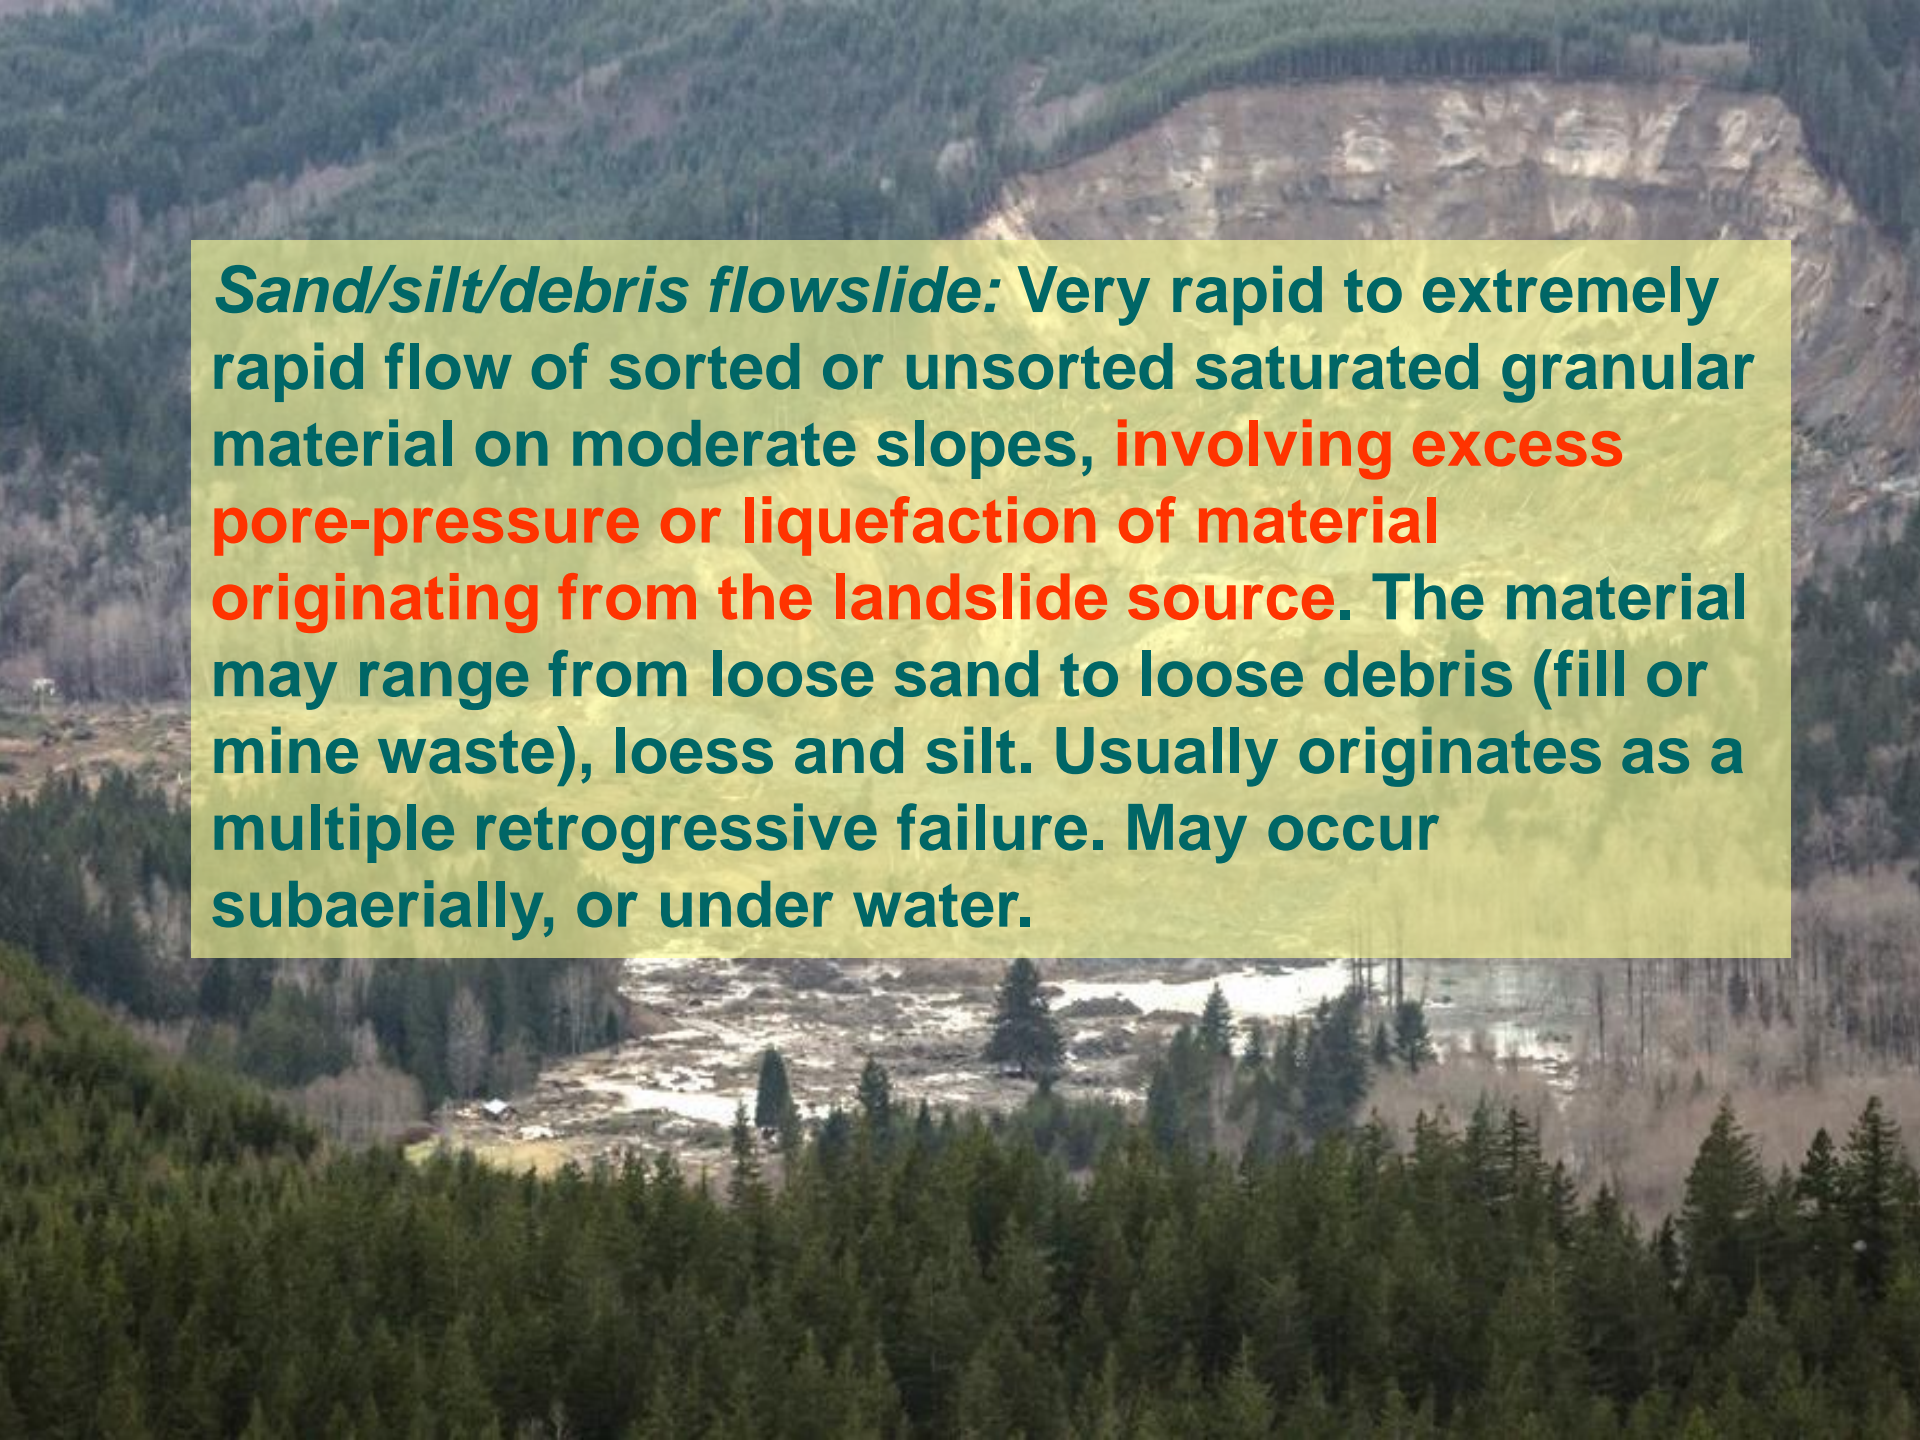
An aerial photograph showing a large, light-colored debris flow field on a hillside, with a river channel visible in the foreground. The surrounding area is covered in dense green forest.

***Sand/silt/debris flowslide:* Very rapid to extremely rapid flow of sorted or unsorted saturated granular material on moderate slopes, involving excess pore-pressure or liquefaction of material originating from the landslide source. The material may range from loose sand to loose debris (fill or mine waste), loess and silt. Usually originates as a multiple retrogressive failure. May occur subaerially, or under water.**

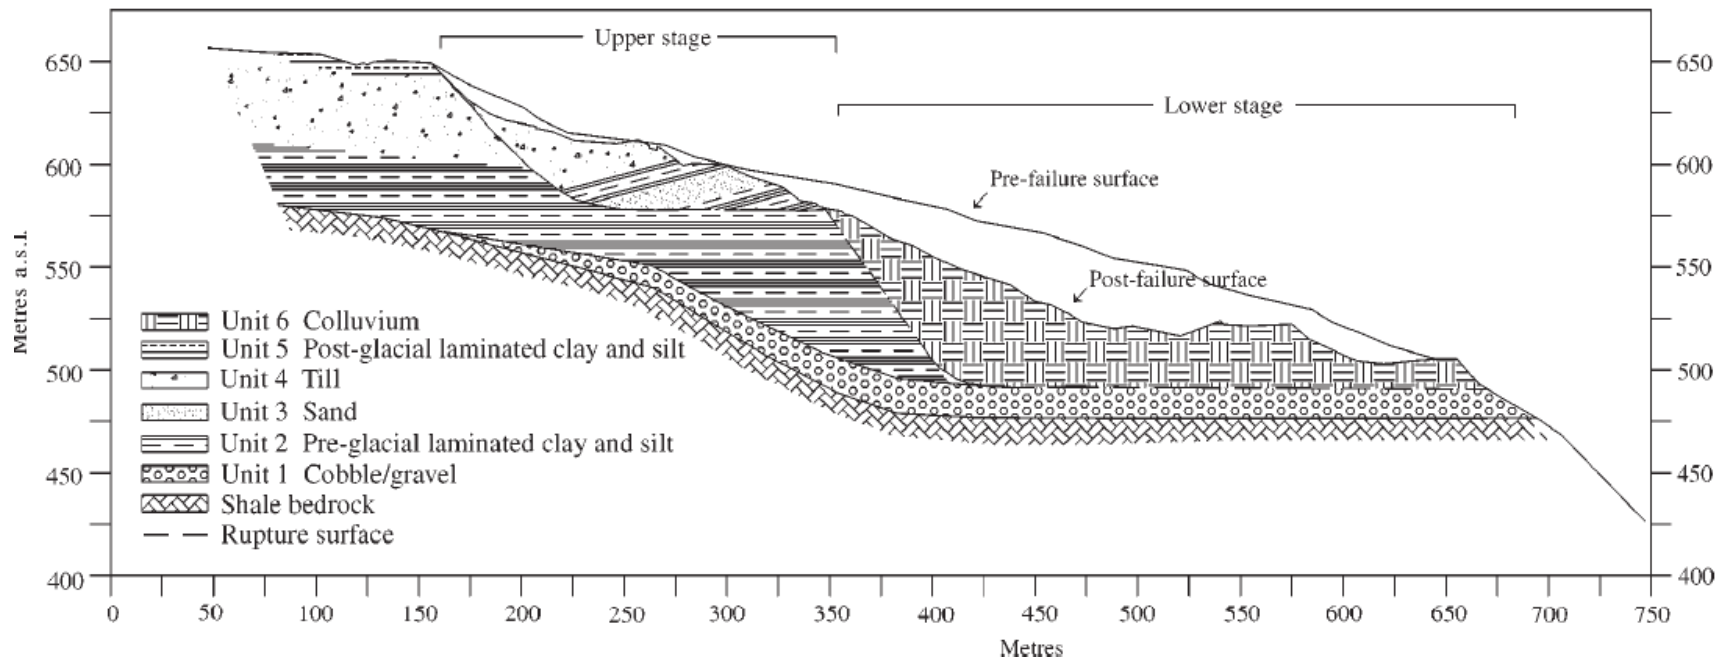
Property	Till (<i>n</i> = 3)	Preglacial lake sediments	
		Plastic (<i>n</i> = 38)	Silt (<i>n</i> = 7)
Natural water content (%)	24 (16–35)	31 (20–37)	—
Liquid limit (%)	38 (33–44)	41 (27–59)	30 (NP to 34)
Plastic limit (%)	17 (8–22)	21 (14–27)	21 (NP to 24)
Plasticity index (%)	17 (17–22)	18 (8–34)	9 (NP to 12)
Liquidity index (%)	0.27 (–0.01 to 0.57)	0.19 (–3.18 to 0.59)	—
Clay content (%)	31 (19–37)	46 (28–68)	16 (7–27)
Silt content (%)	46 (25–63)	54 (32–72)	84 (73–91)
Bulk density (kg/m ³)		1947* (1846–2171)

These materials are neither collapsive nor sensitive (Fletcher et al., 2002)

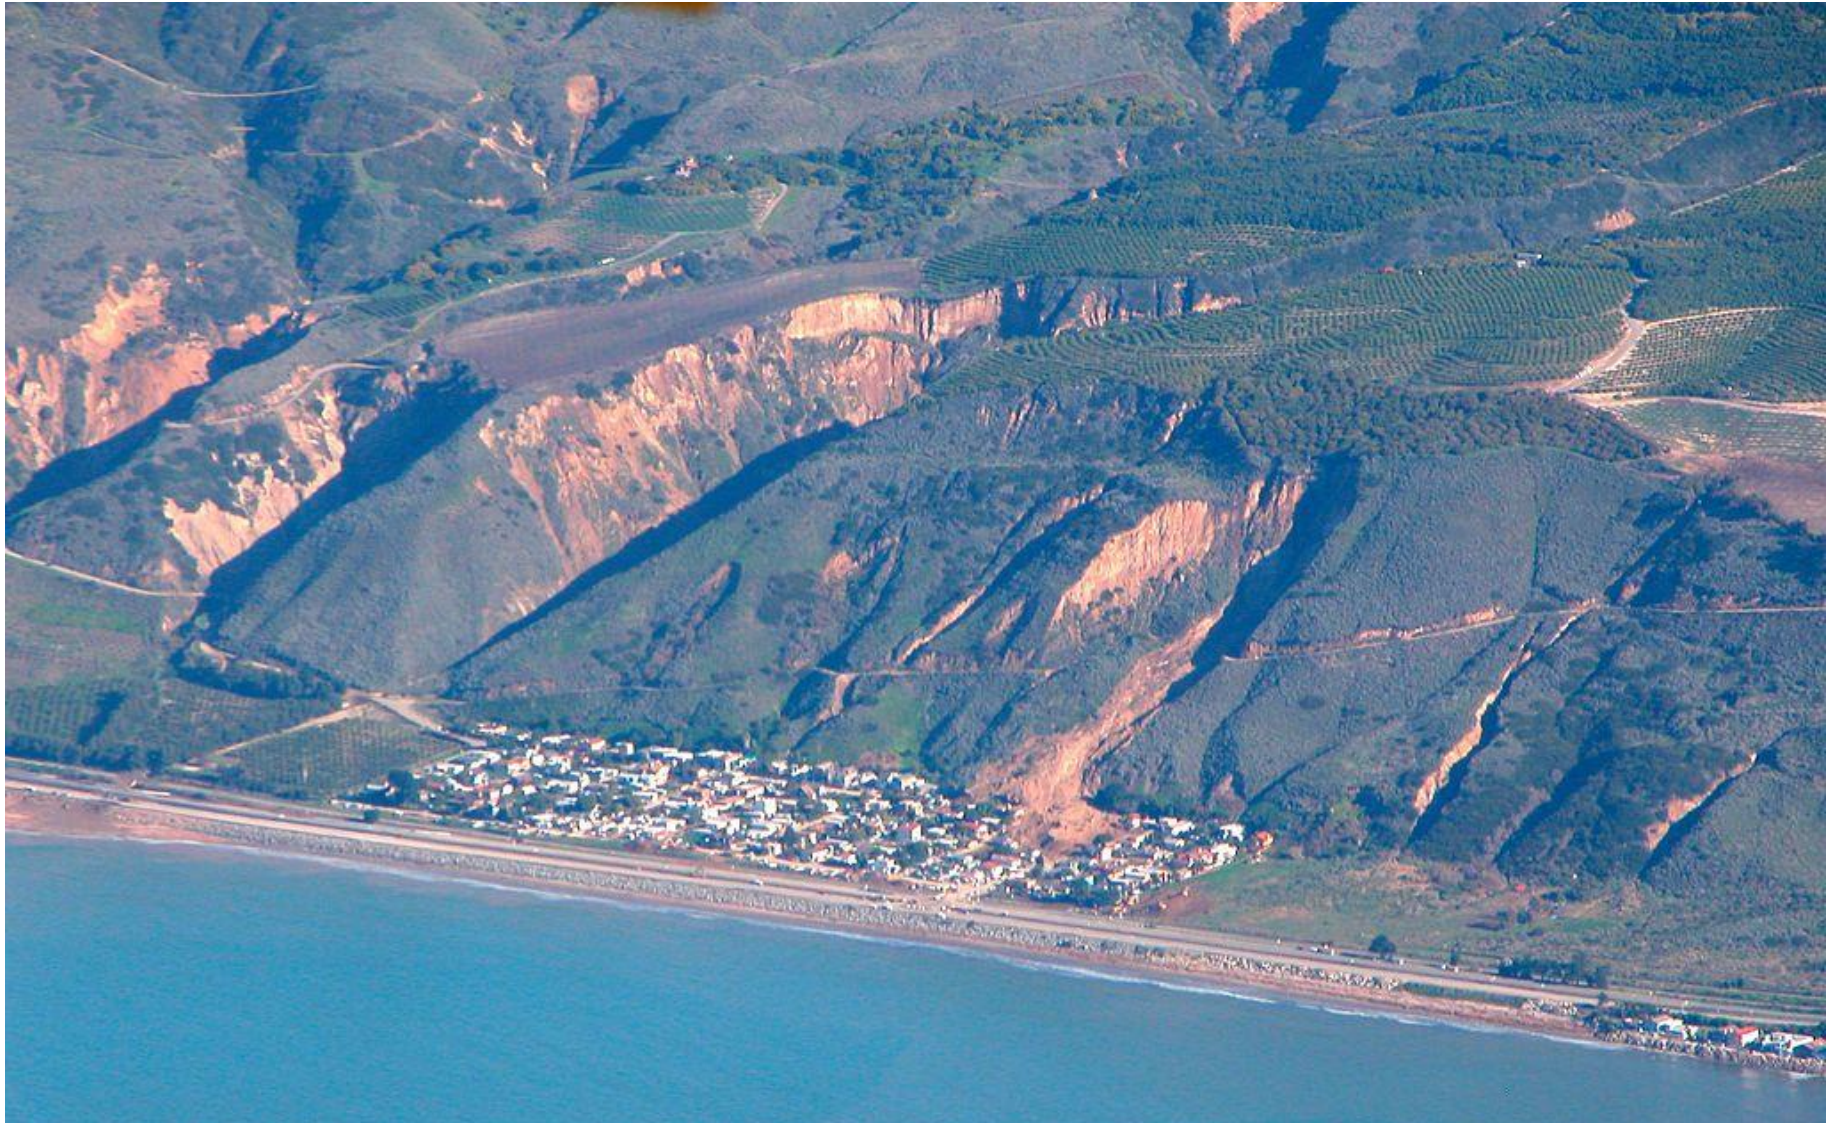
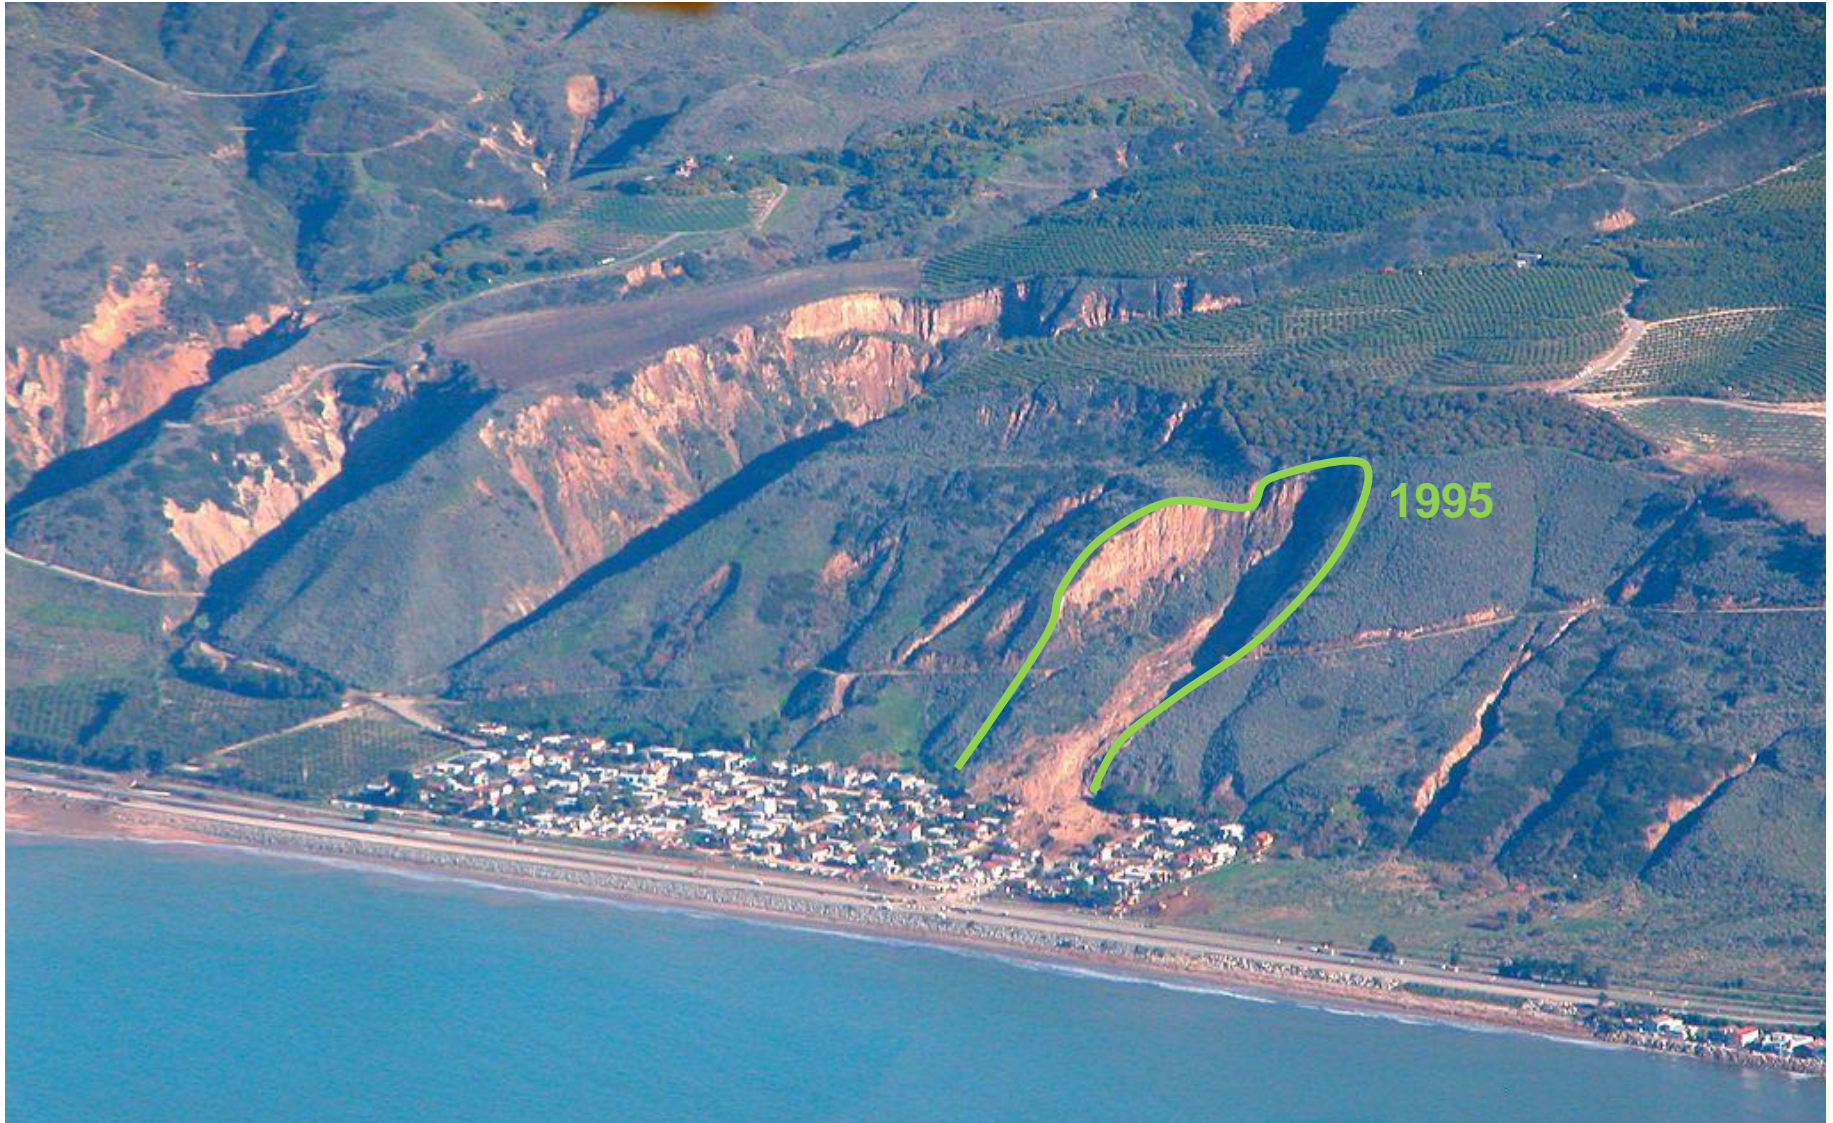
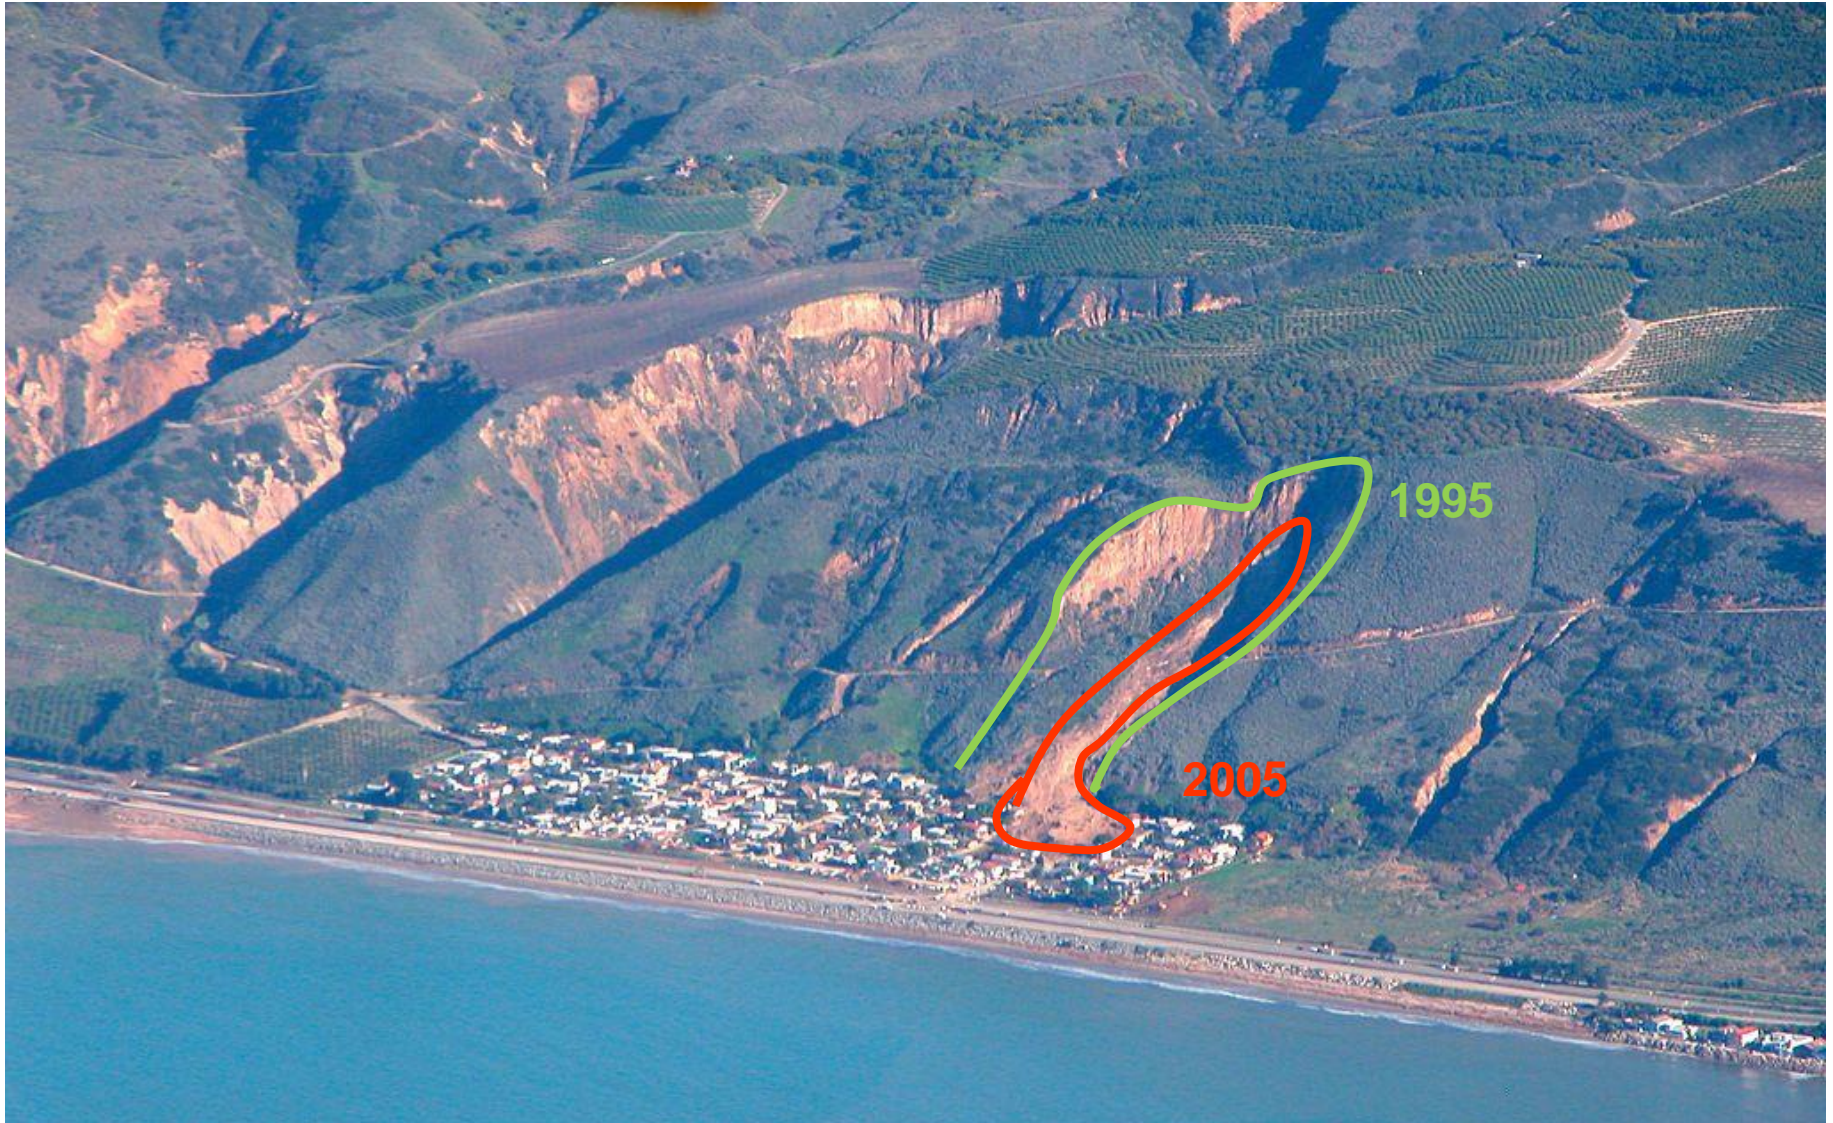
La Conchita, California, 1996 and 2005 (Jibson, 2005)

Terrace of poorly indurated Tertiary marine sediment. Interlayered siliceous shale, siltstone, and sandstone.

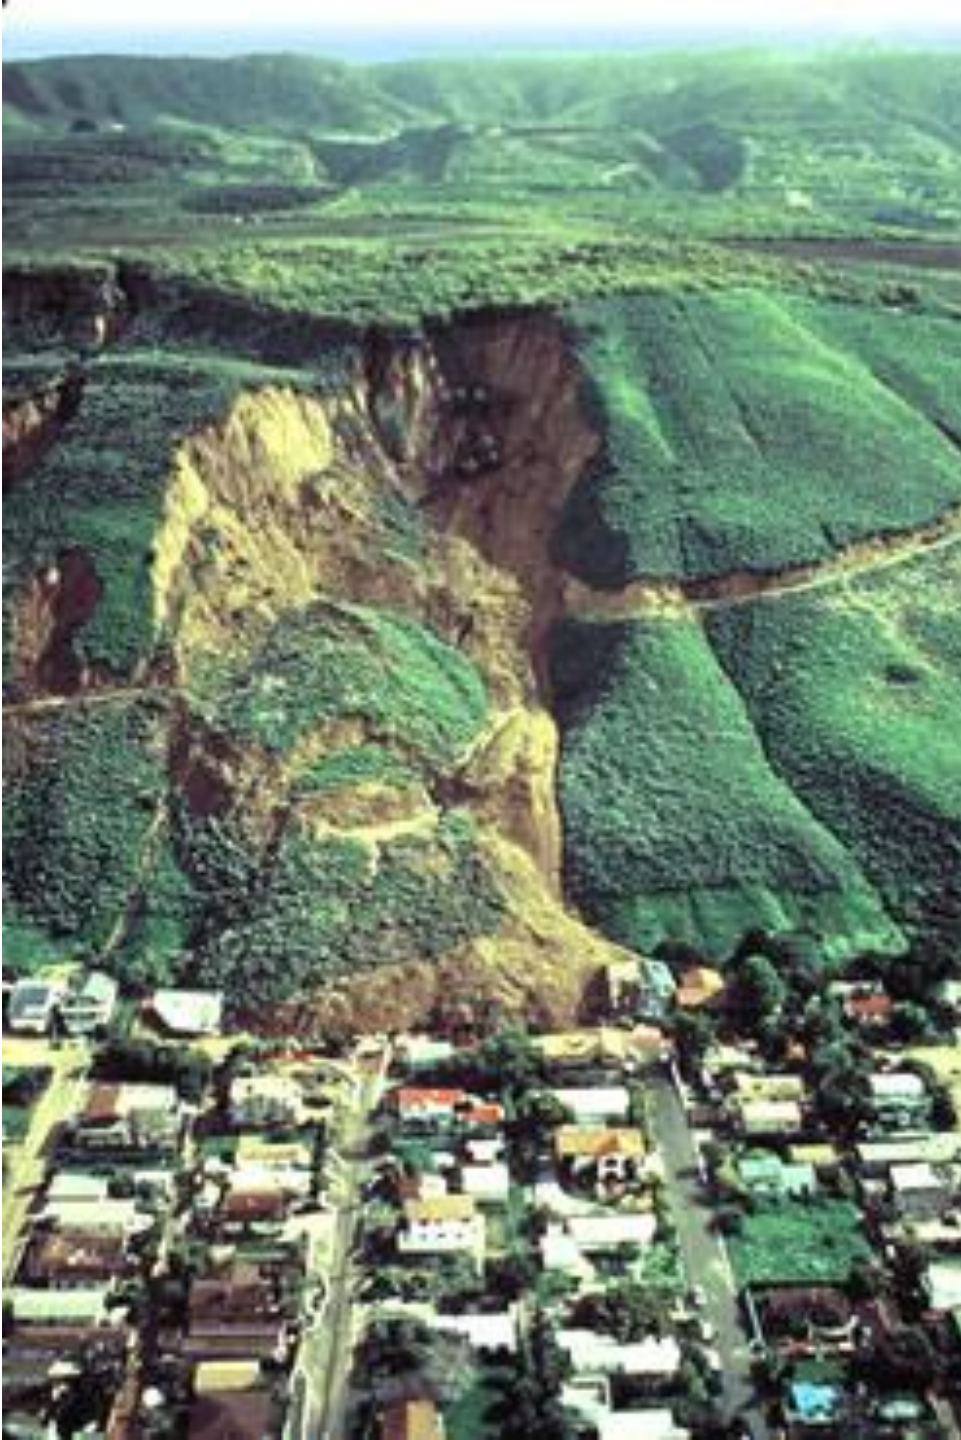
1995 event: earth flow

- Following spring with 100% above average precipitation.
- 1 month delay between precipitation and failure
- Moved “tens of metres in a few minutes” (slow-rapid)
- Houses damaged, but no injuries.

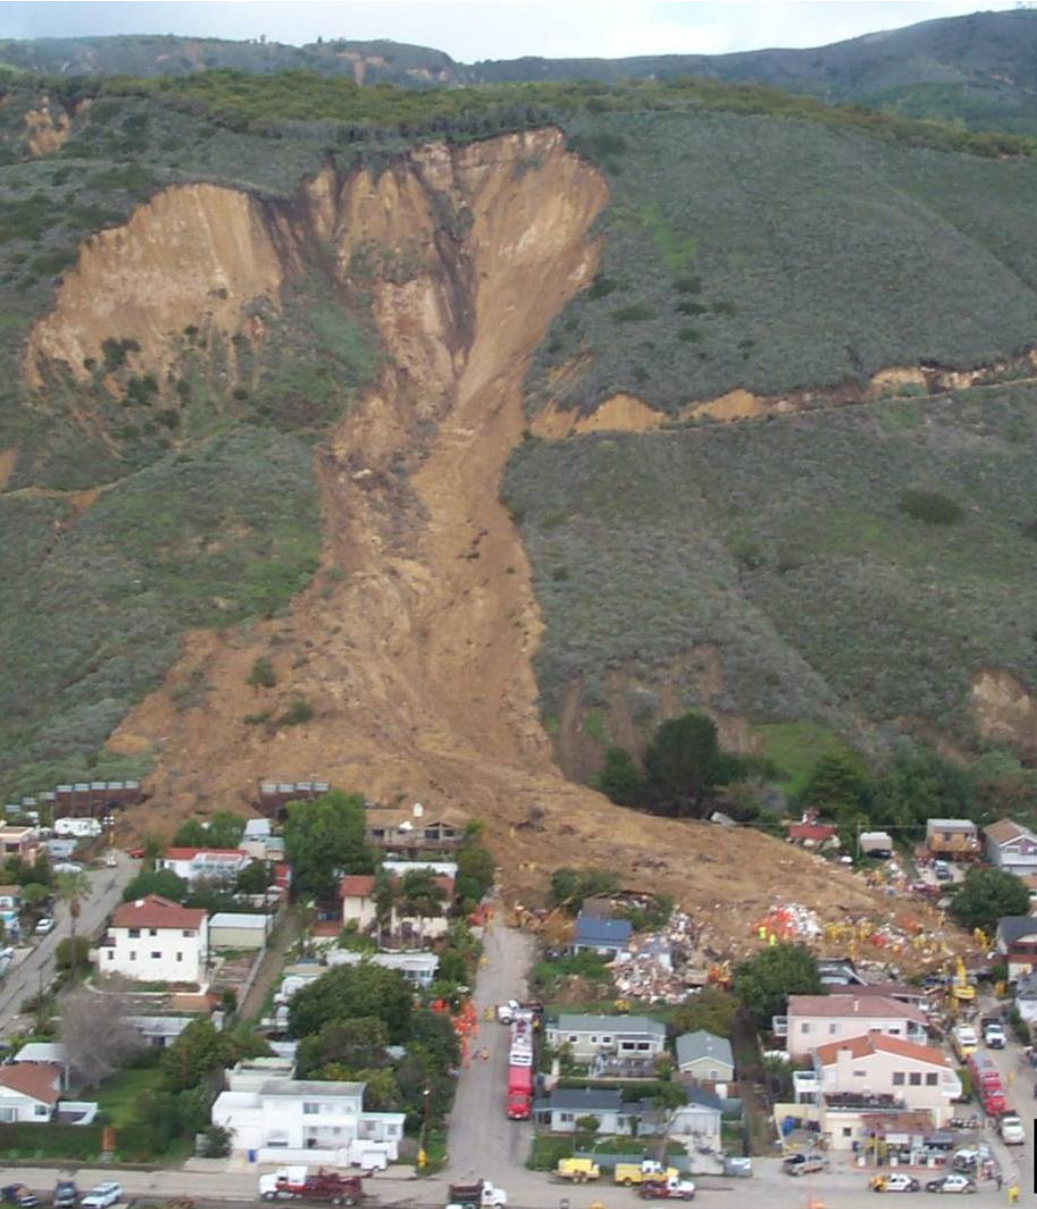
2005 event: flowslide

- Remobilized 1995 debris
- Following the day with maximum daily precipitation.
- Moved “tens of metres in a few seconds” (extremely rapid)
- Several houses destroyed, **10 fatalities**.

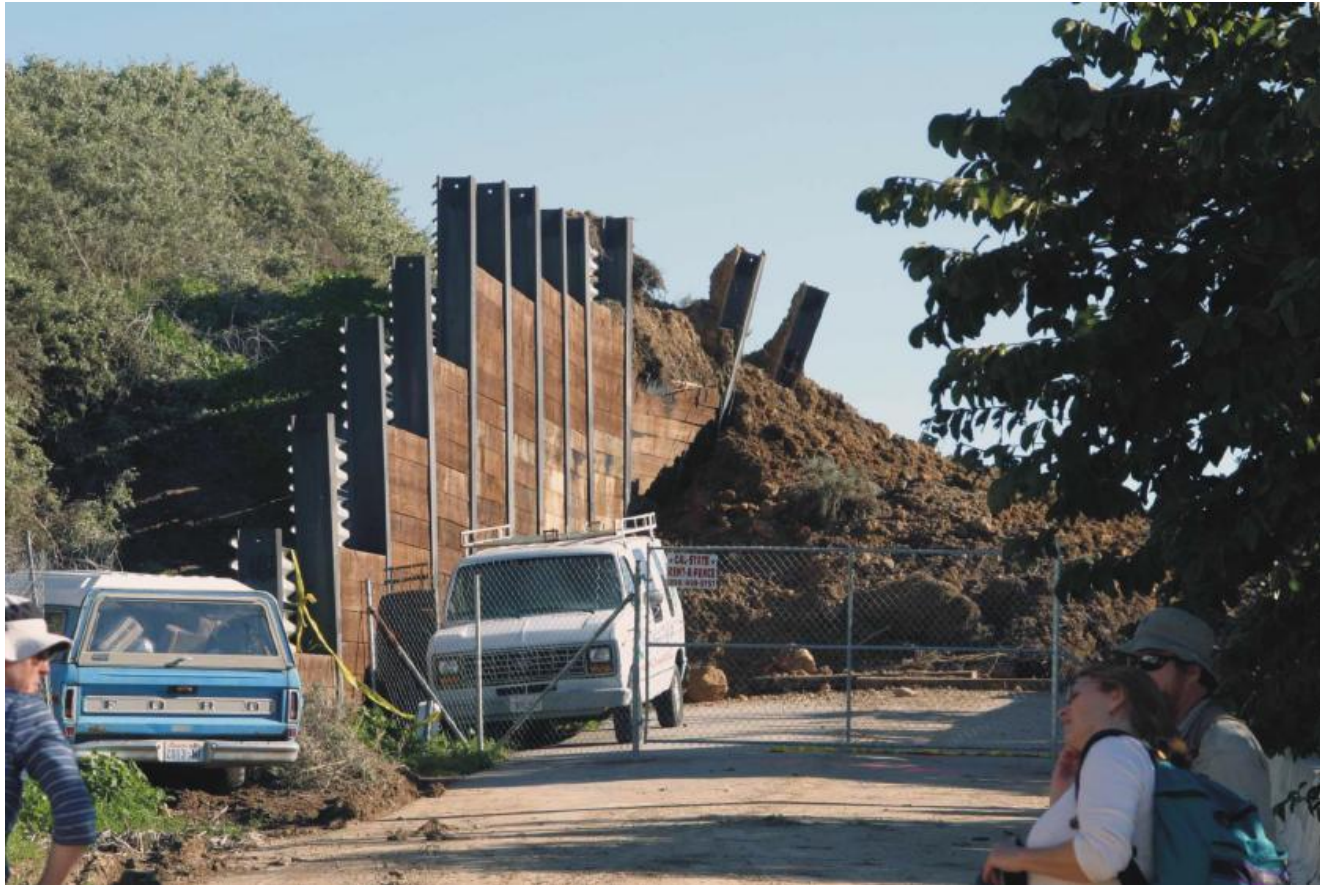
“A highly hazardous situation involving a two-phased landslide mechanism: (1) a saturated, highly fluid layer at depth on which the landslide mobilized that (2) carried a thick layer of drier, much more viscous material that effectively acted as a battering ram.” (Jibson, 2005)

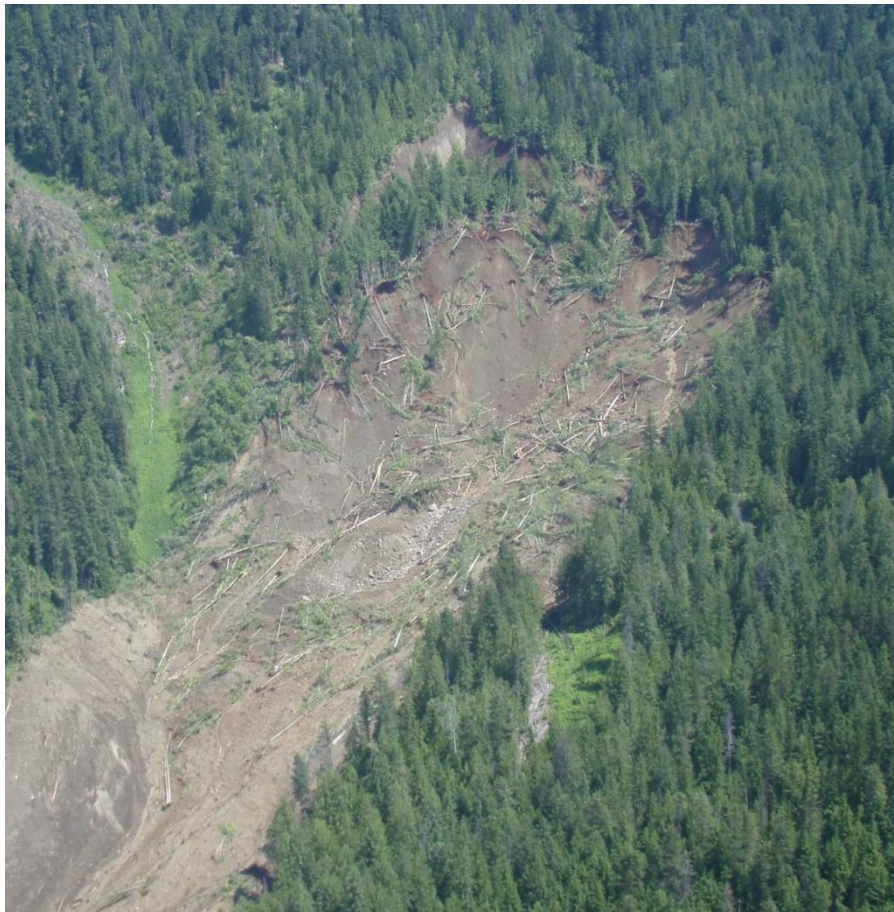
Pre-event geomorphological mapping:

Source area is situated in a geomorphological unit described as sandy moraine and glacio-fluvial soil (kame deposit) – **Failing** (i.e. in an unstable condition). Stability Class III (out of 5)

Deep-seated compound silt slide
320,000 m³

1:500 year rain on snowmelt

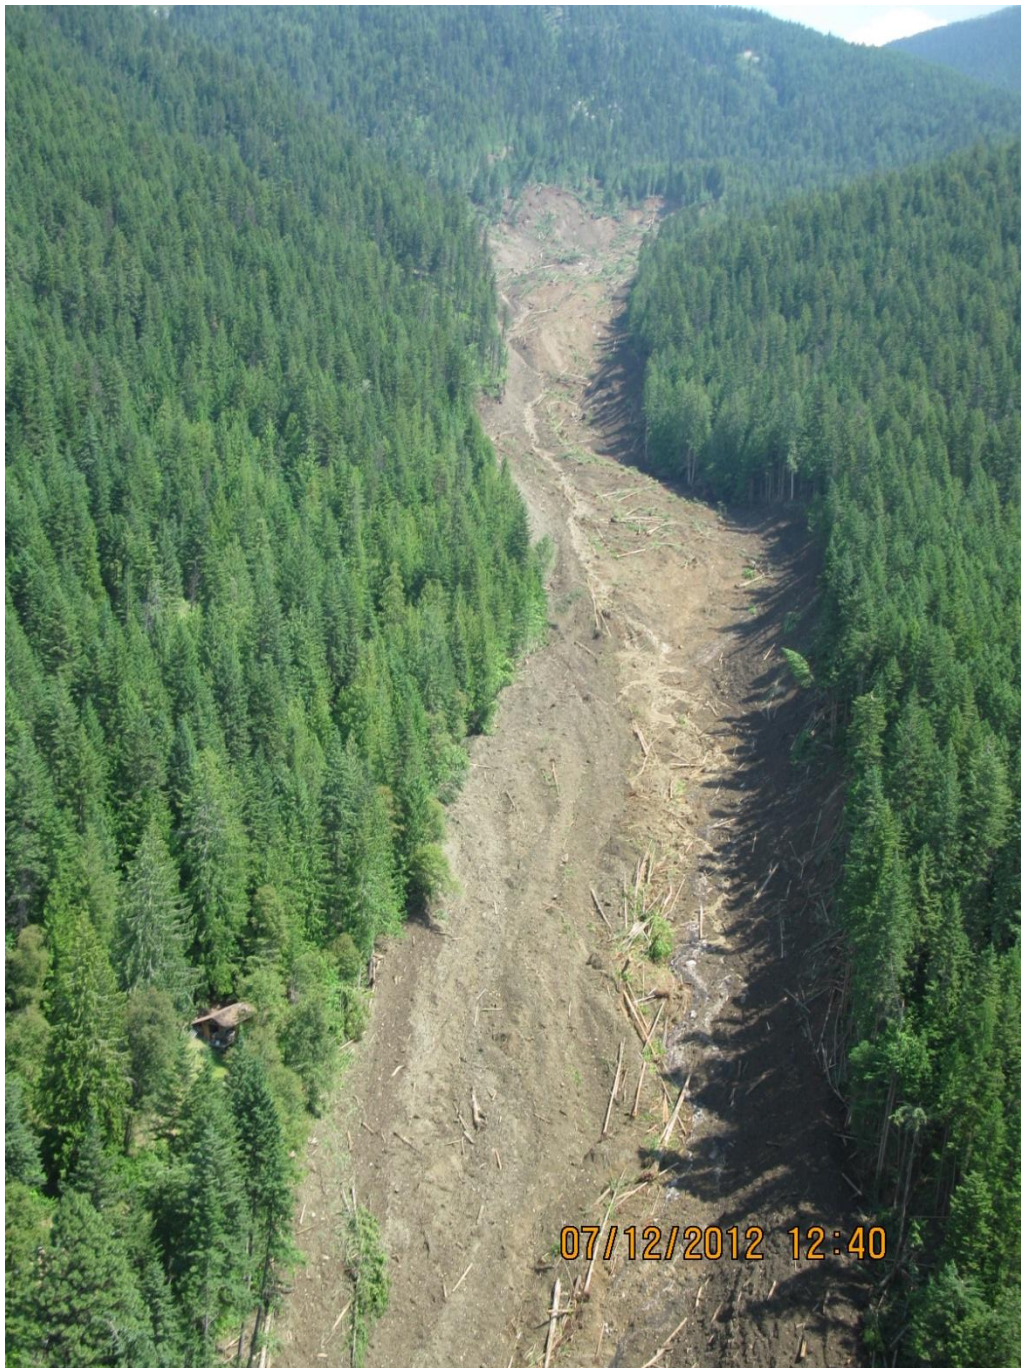
Material: Interbedded glacial till and glacio-fluvial deposits, mostly silty sand in texture, mostly non-plastic, a few clayey silt interbeds, based on weak, unstable bedrock

**Source volume:
320,000 m³**

**Minor soil
entrainment, large
quantities of timber
debris**

**Flow velocity from
eyewitness
accounts: > 20 m/s**

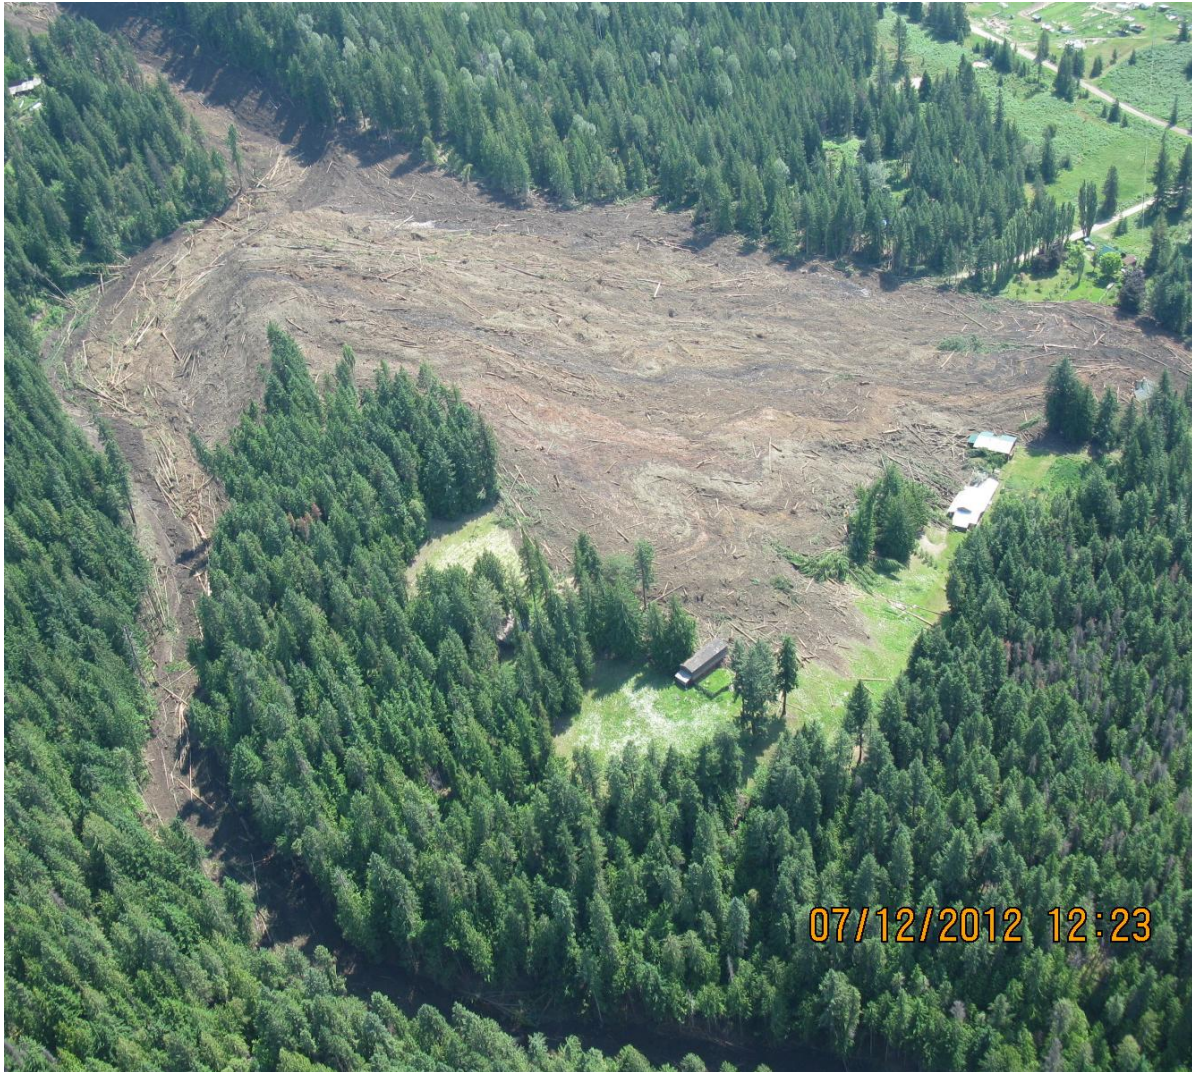
Deposit:

6 houses
destroyed,
4 fatalities

This is the first
landslide deposit
on top of a glacio-
fluvial terrace
surface, over
9,000 years old

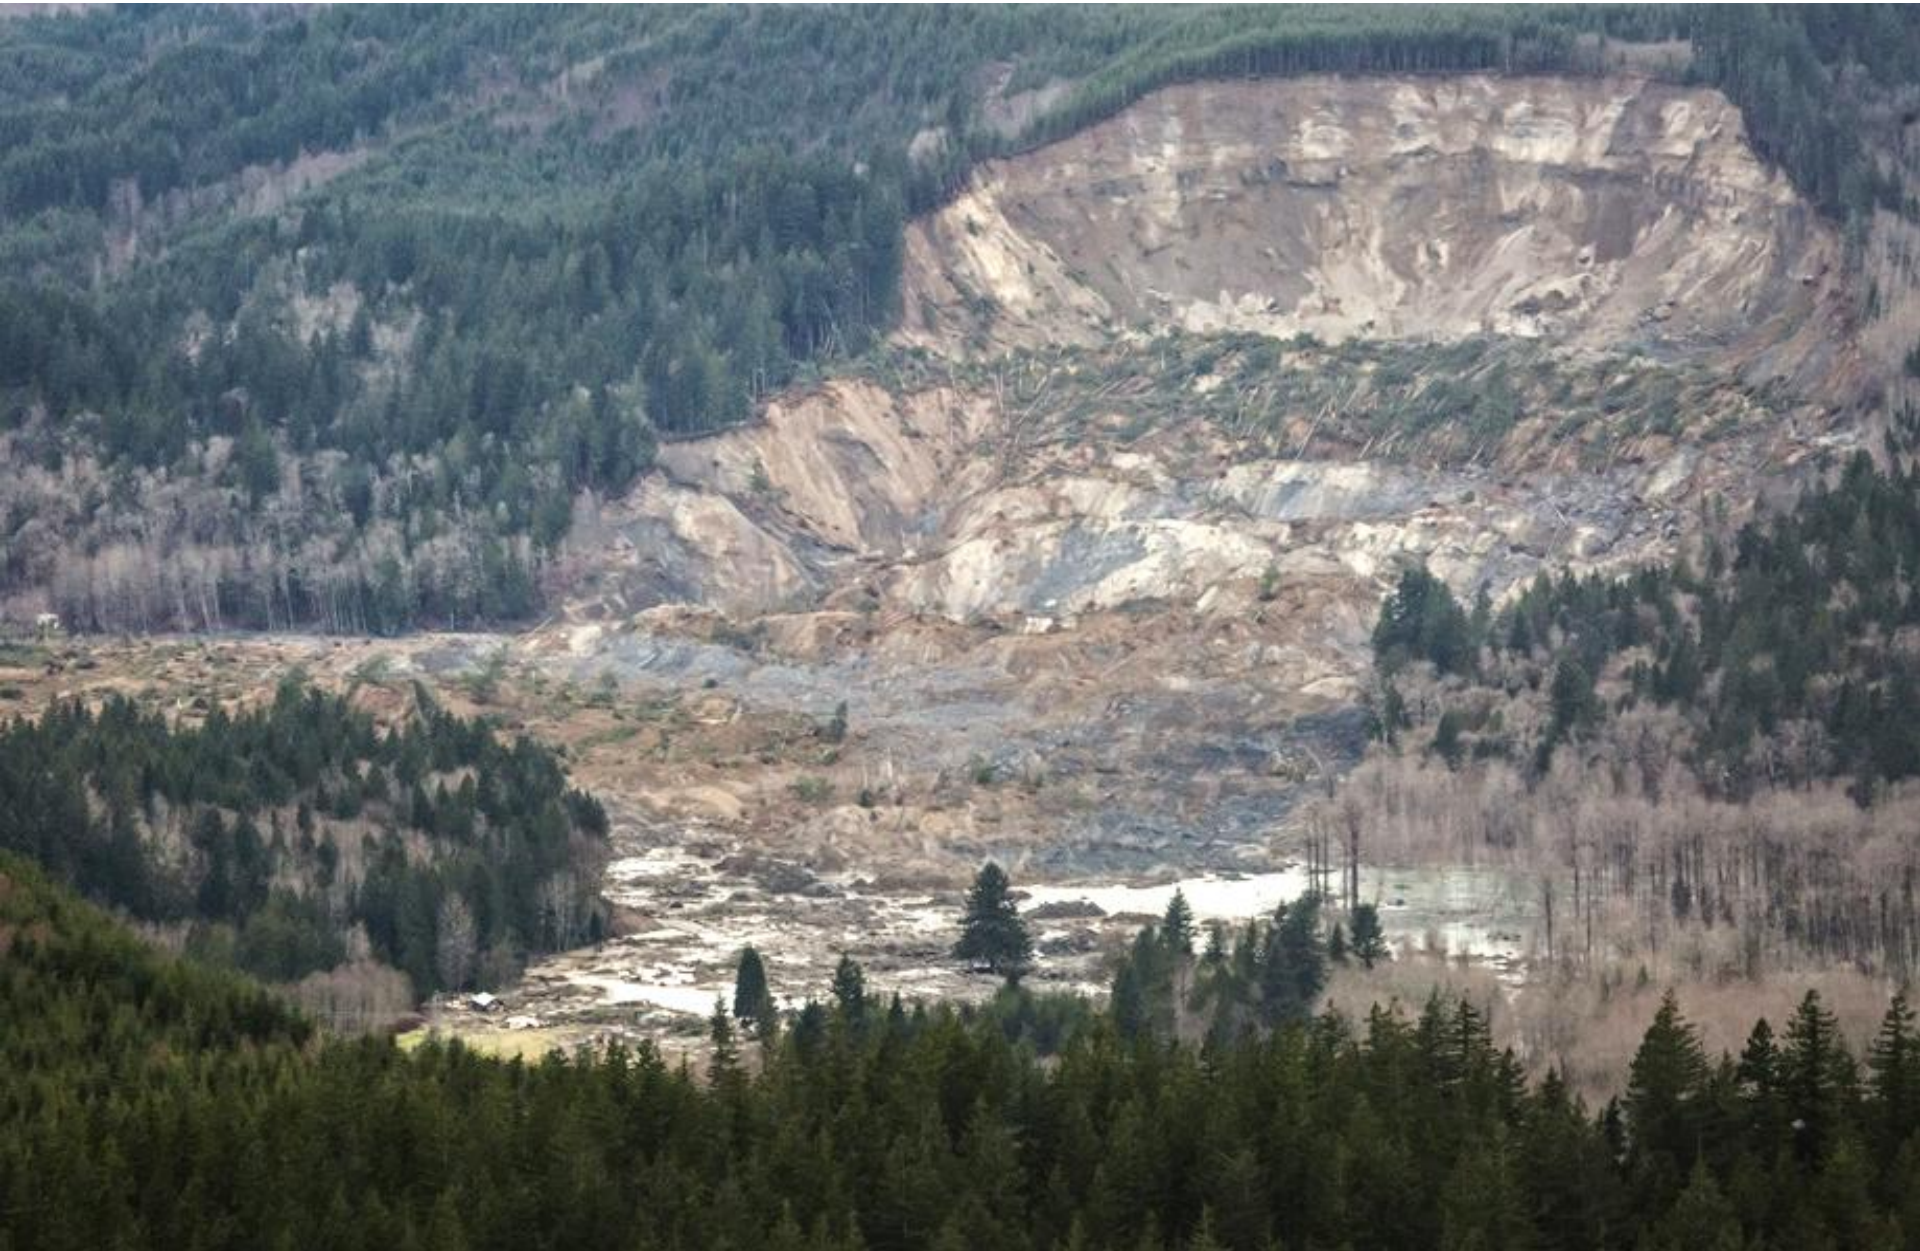
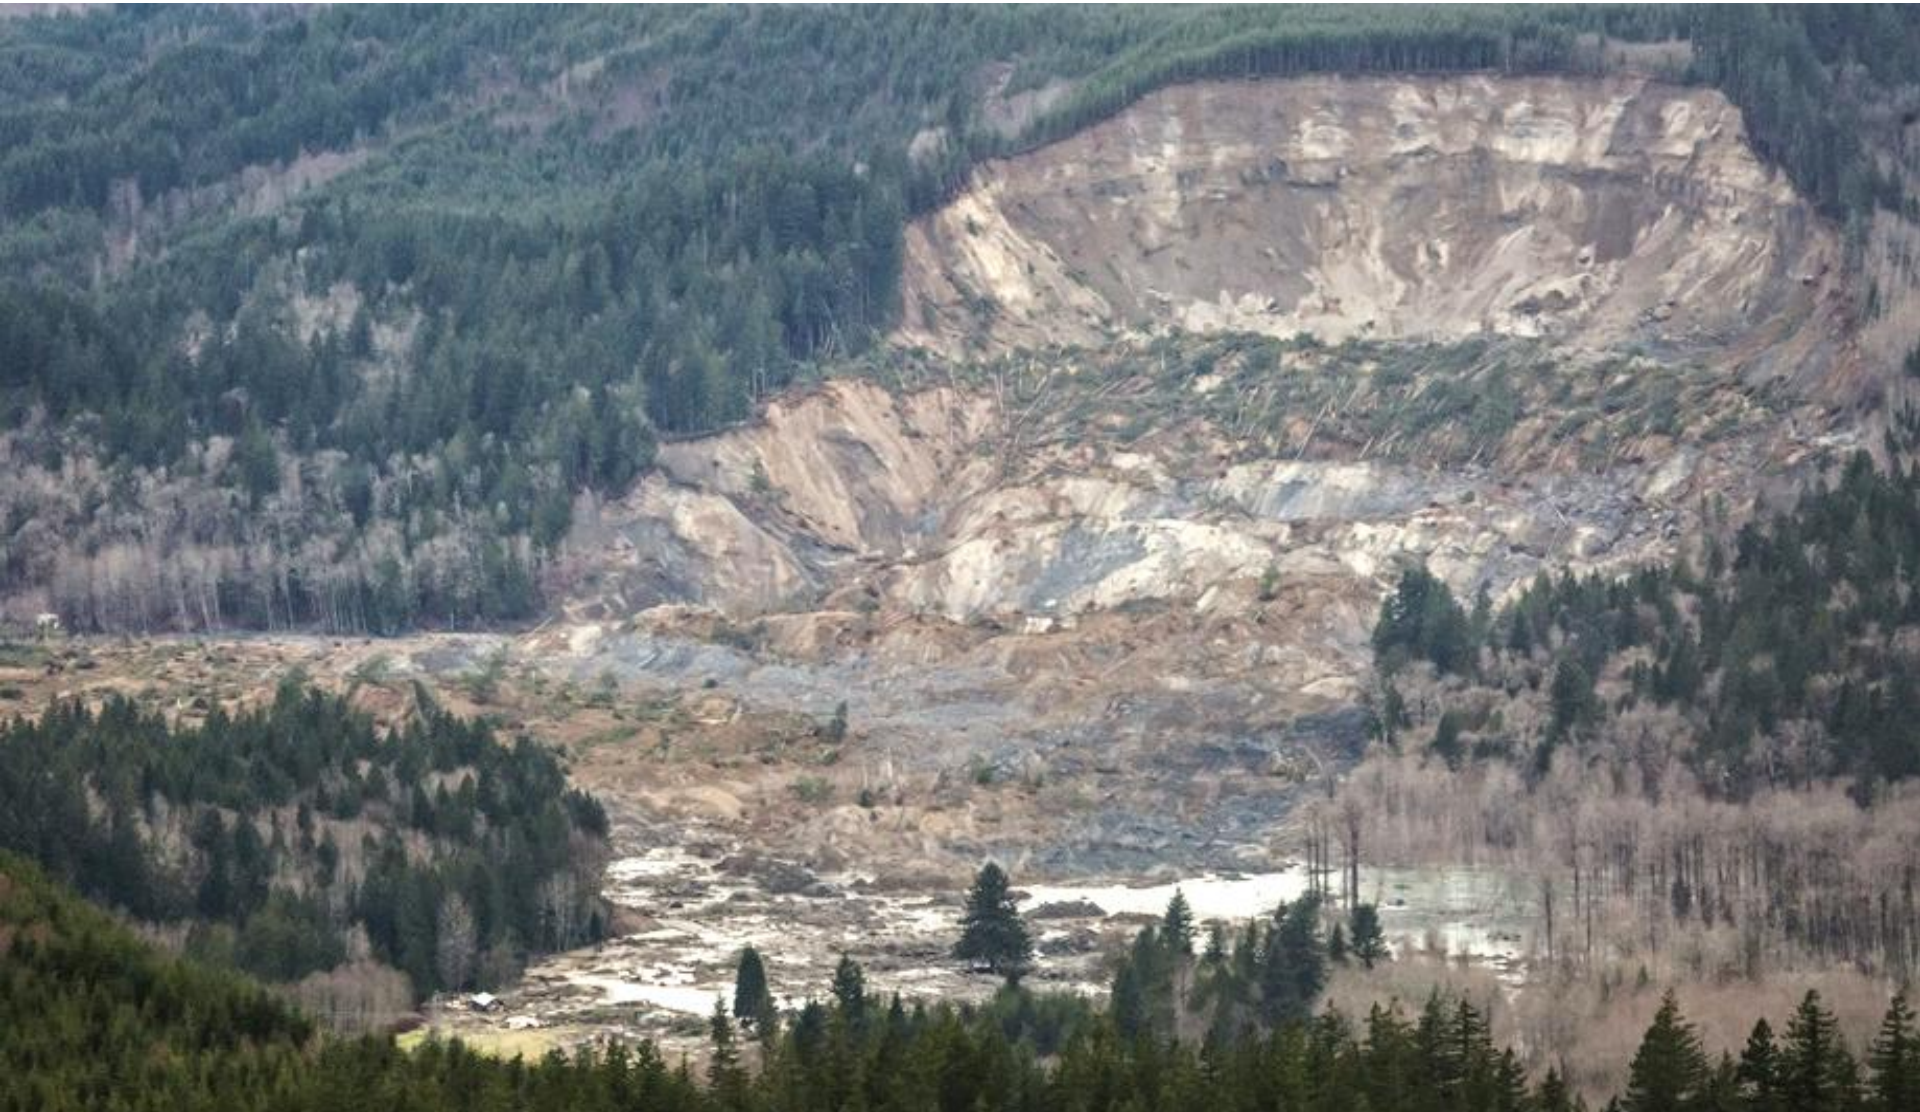
Oso Slide, Northern Washington, USA, March 22, 2014

7.6 million m³

Community destroyed, 43 fatalities, \$50 million cost

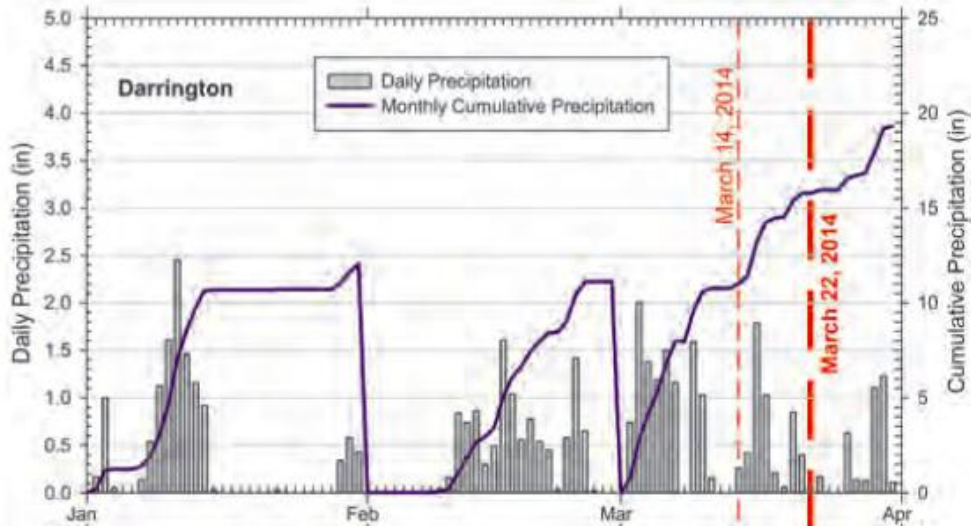
Daily and monthly precipitation
- 20 km away
