Non-textbook Flowslides in Fine-grained Colluvium

Oldrich Hungr

University of British Columbia, Canada

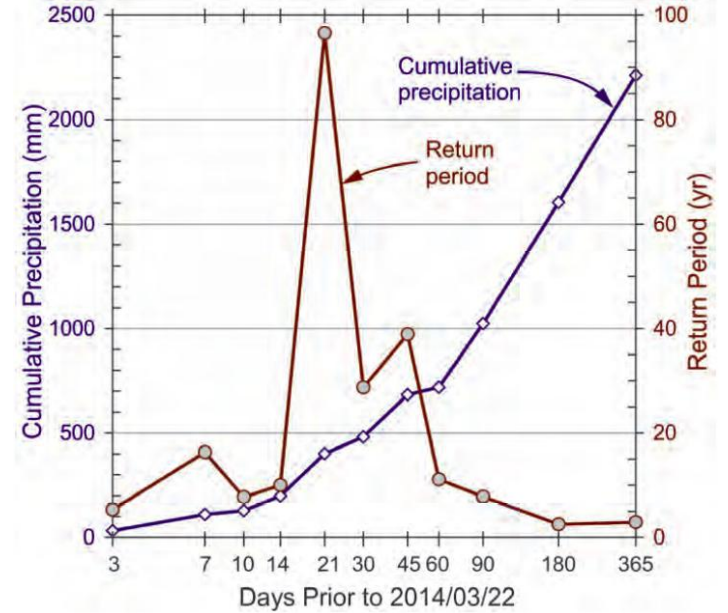
Frequency/duration analysis
Radar indicates local precipitation could have been higher (NSF, 2014)

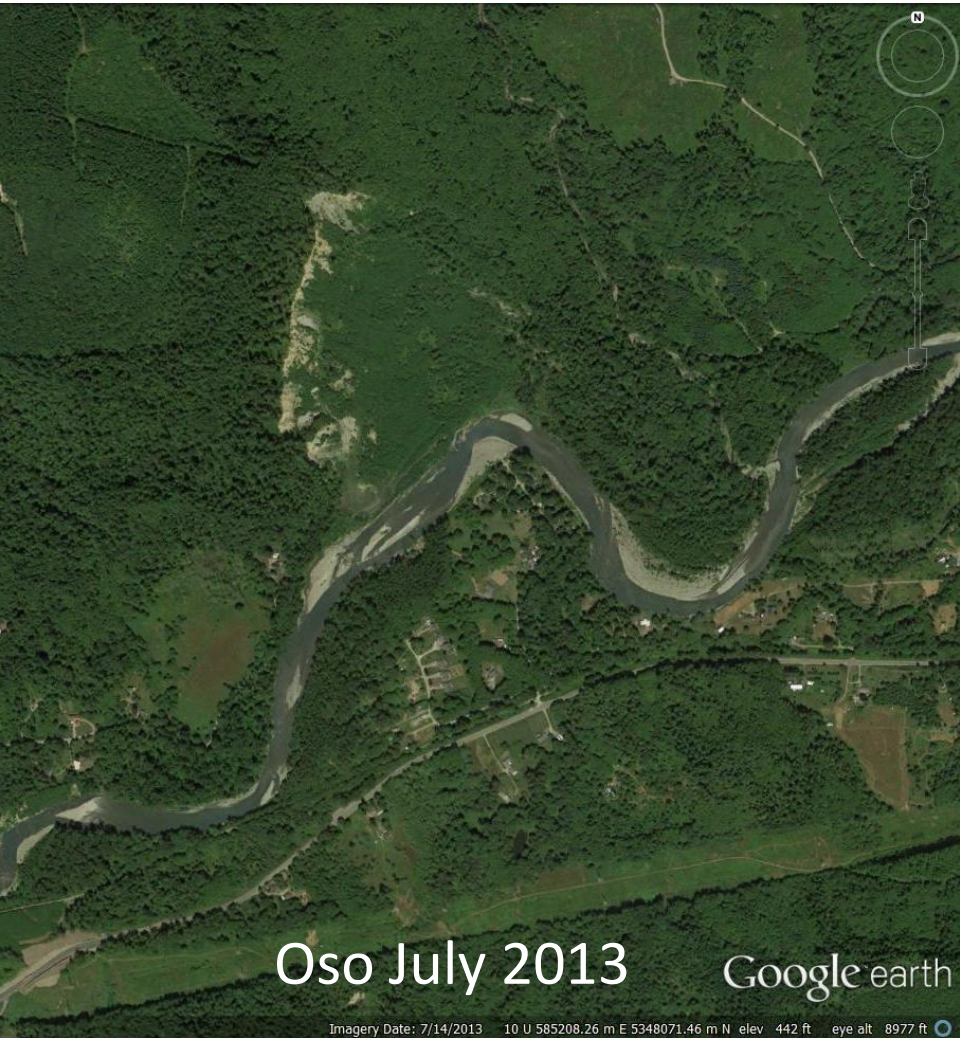
Oso July 2013

Imagery Date: 7/14/2013 10 U 585208.26 m E 5348071.46 m N elev 442 ft eye alt 8977 ft

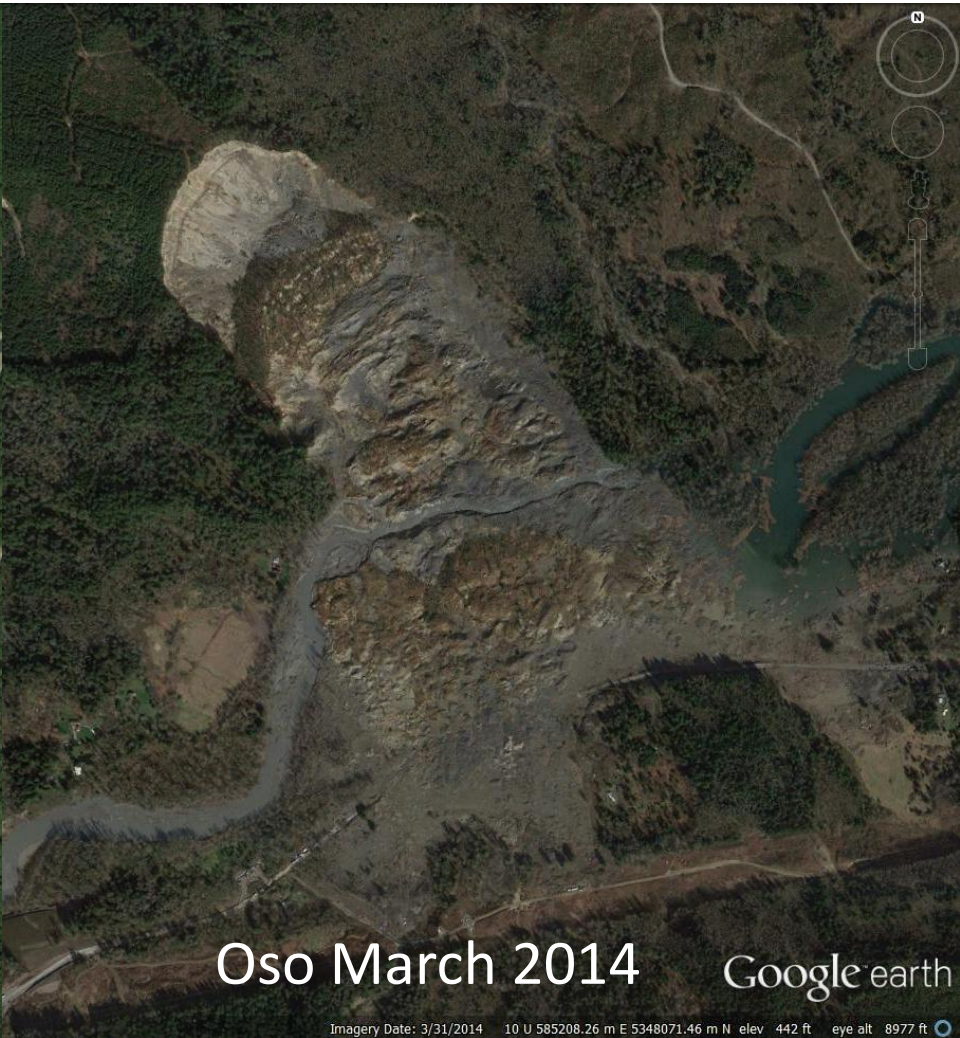
Oso March 2014

Imagery Date: 3/31/2014 10 U 585208.26 m E 5348071.46 m N elev 442 ft eye alt 8977 ft

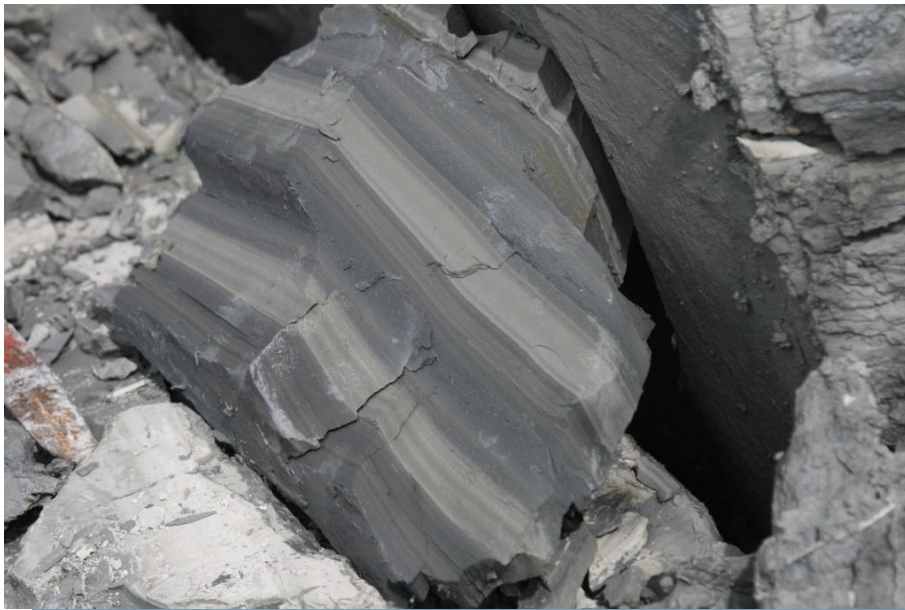
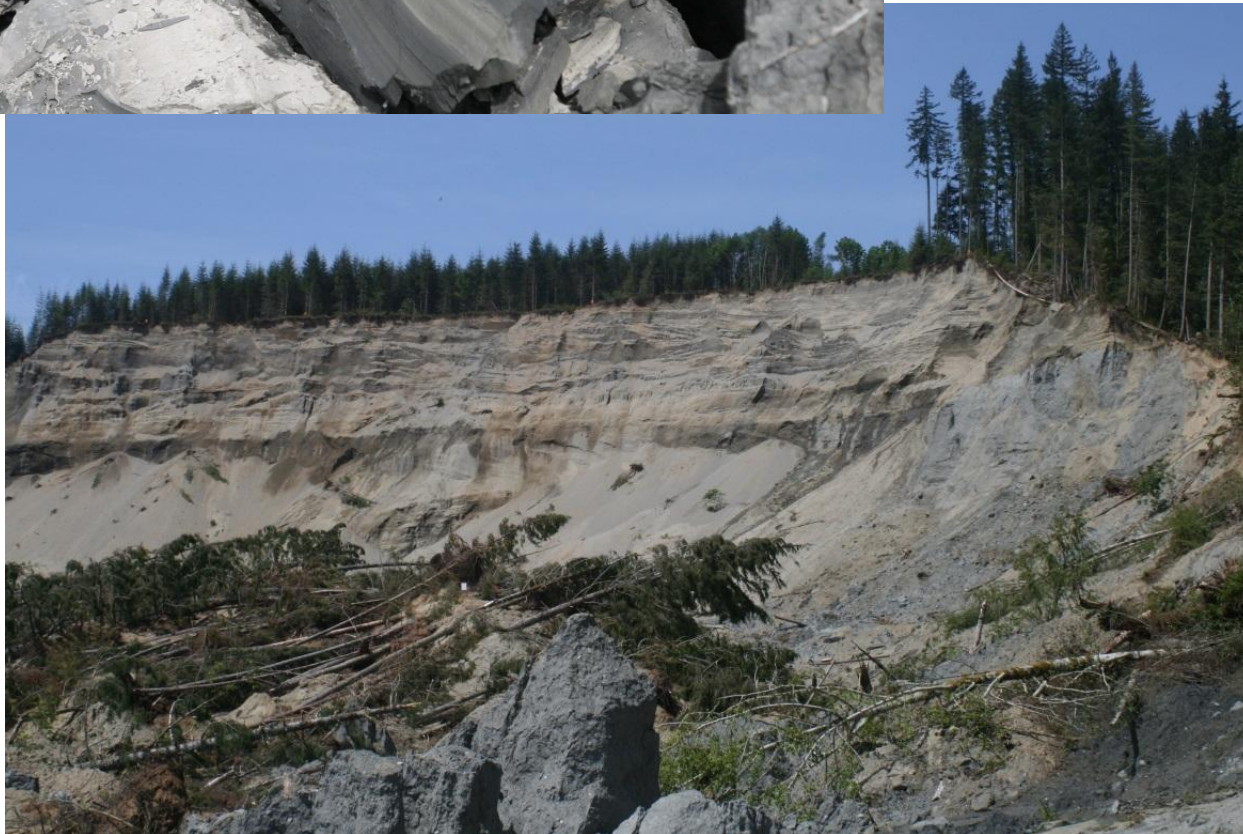
Material:

Glacio-lacustrine clay and silt
Described as “hard” in
drillholes
Collapsible??

Overlying
sand and
glacial till

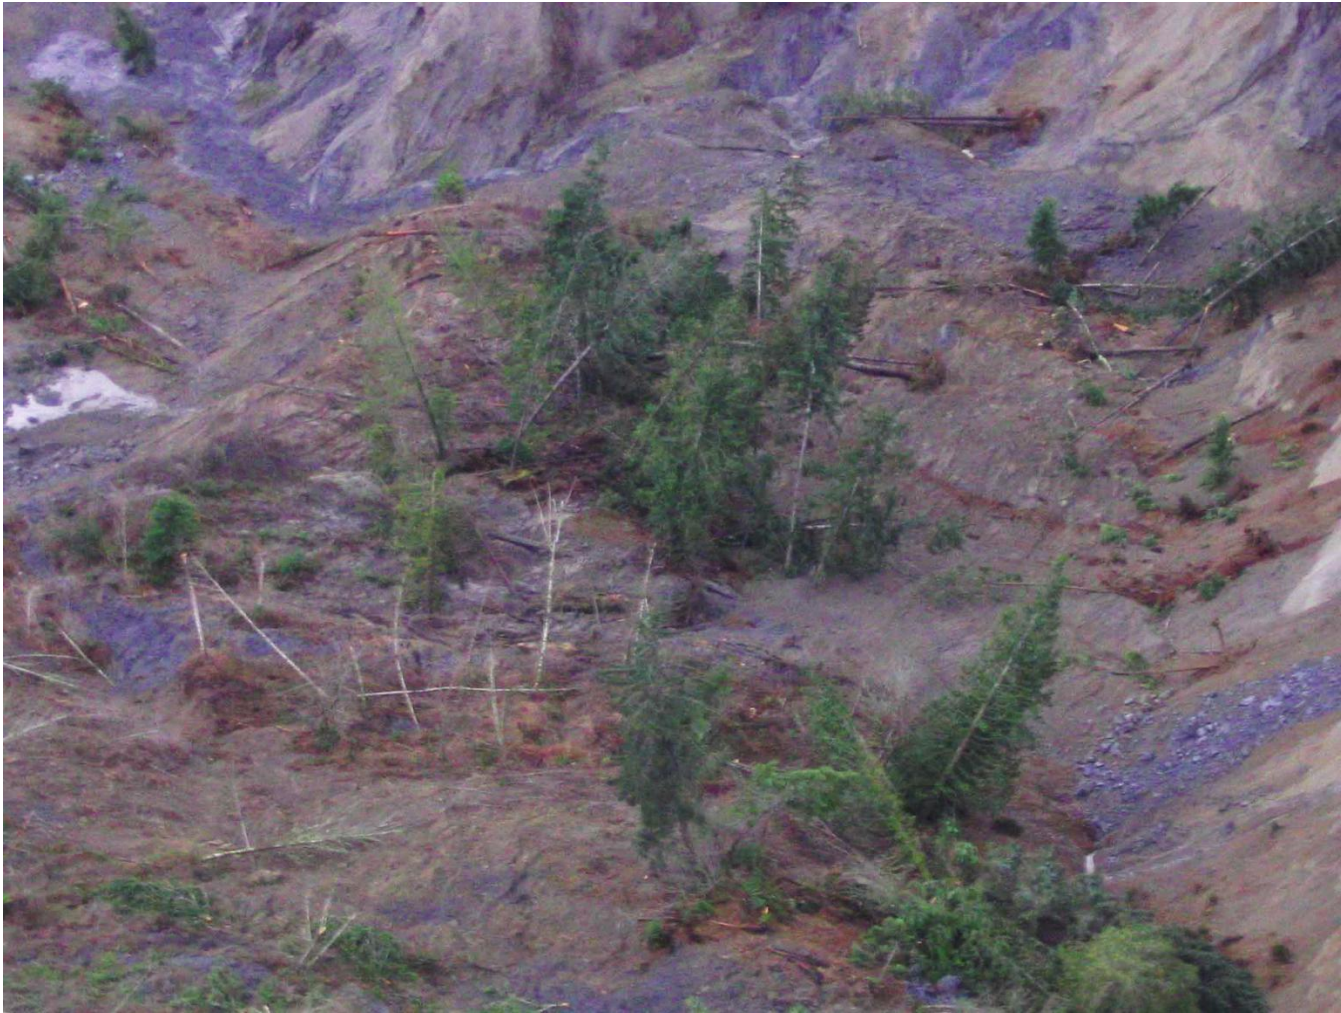
Material:

Colluvium from the 2006 and earlier slides. Liquefiable?
